SURVEY PLAN

**HOVELSRUD CONSULTING ASSOCIATES
ENGINEERING - LAND SURVEYING
RICHLAND COUNTY BANK BUILDING
RICHLAND CENTER, WISCONSIN 53581**

Sheet 2 of 2
Survey for: Ahren's Realty

Line located in the Southwest Quarter (SW ¼) of the Southwest Quarter (SW ¼) of Section 20, T. 6 N., R. 5 W., Grant County, Wisconsin.

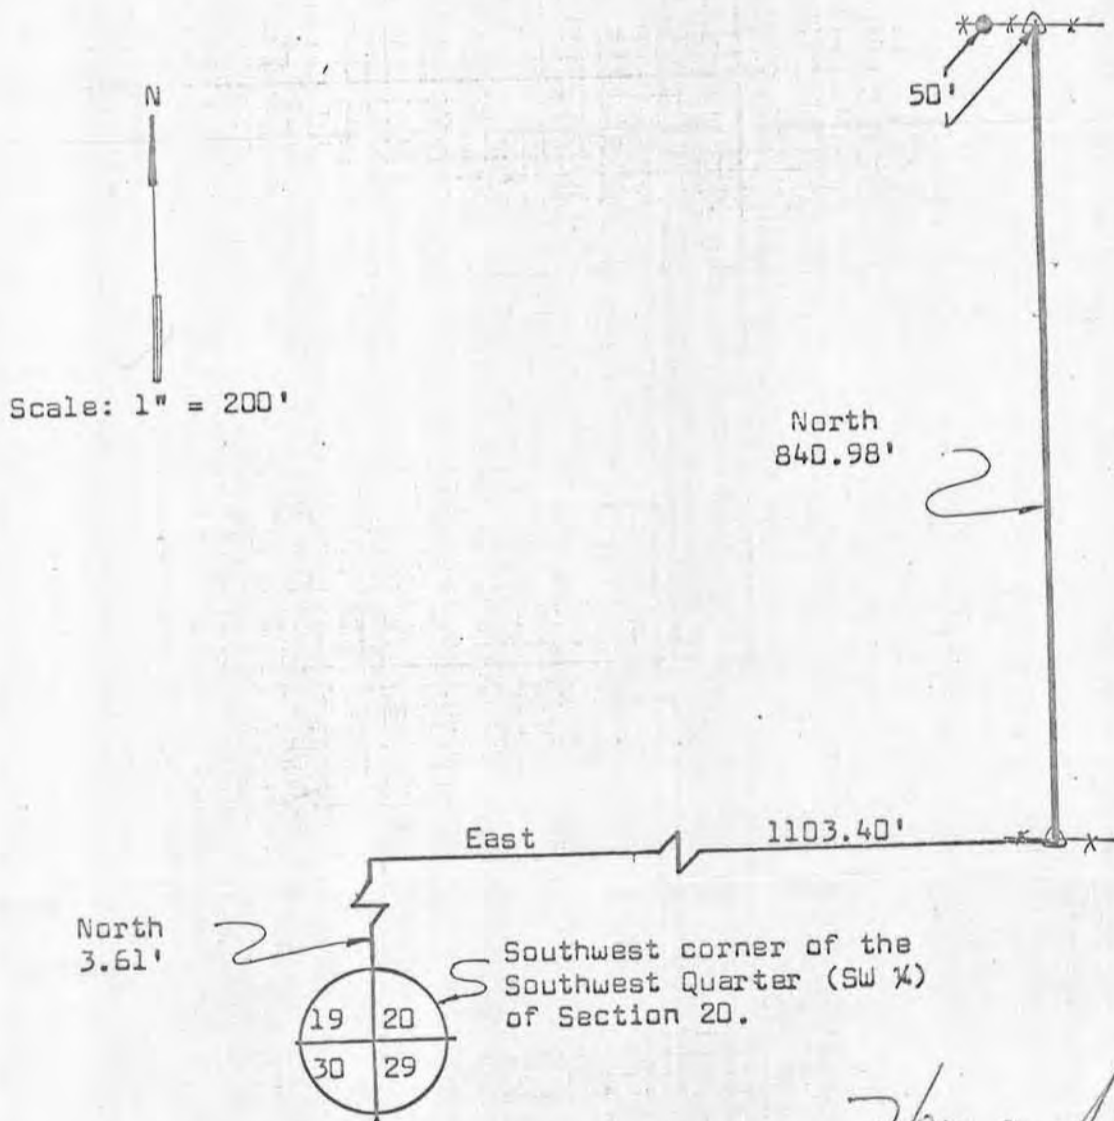
- △ 3/4" diameter X 24" reinforcing bar placed, min. wt. 1.50 lbs./ lin. ft.
- existing fence post painted red
- x—x— existing fenceline

Commencing at the Southwest corner of the Southwest Quarter (SW $\frac{1}{4}$) of Section 20, T. 6 N., R. 5 W., Grant County, Wisconsin; Thence North, 3.61 feet; Thence East, 1103.40 feet to a 3/4 inch diameter reinforcing bar in an existing fenceline and the point of beginning;

Thence North, 840.98 feet to a 3/4 inch diameter reinforcing bar in an existing fenceline and the end of said line;
