**GRANT COUNTY  
U.S. PUBLIC LAND SURVEY MONUMENT RECORD**

SECTION 3  
TOWNSHIP 4 NORTH, RANGE 1 WEST  
TOWN OF LIMA

EAST 1/4 CORNER  
SECTION 3  
TOWN 4 NORTH  
RANGE 1 WEST  
LIMA TOWNSHIP  
GRANT CO., WISC.

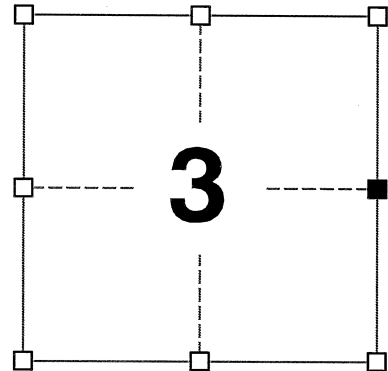
I COULD FIND NO MONUMENTS OR BEARING TREES FROM THE ORIGINAL GOVERNMENT SURVEY. I RECOVERED THE 1" REBAR AT THE FENCE CORNER REPORTED BY BOWDEN. I ACCEPTED THIS LOCATION AS THE BEST AVAILABLE EVIDENCE OF THE ORIGINAL GOVERNMENT CORNER AND REMONUMENTED IT WITH A 2" x 30" STAINLESS STEEL PIPE WITH A 4" GRANT COUNTY BRASS CAP.

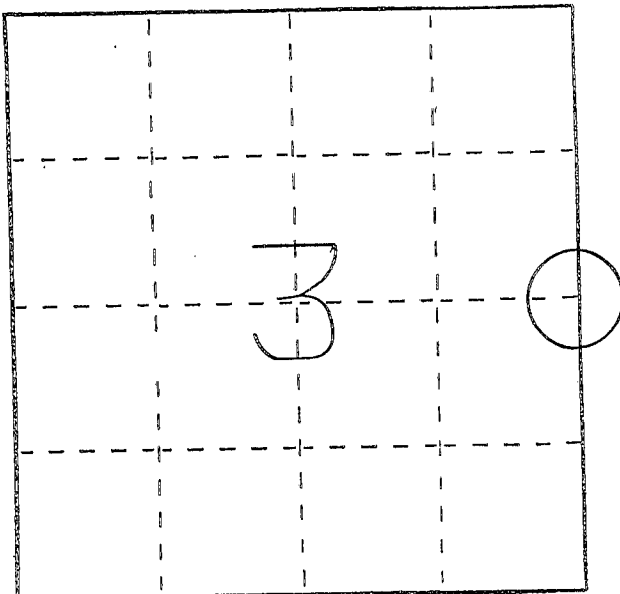
MONUMENT SET FROM EXISTING PHYSICAL EVIDENCE OF ROADS AND FENCES AFTER VERIFICATION BY PROPORTIONATE MEASUREMENTS FROM AN EDM TRAVERSE OF THE AREA.
