Survey Monument Record

CORNER NO. \_\_\_\_\_  
 SECTION 26 MAY 16 1995  
 TOWN 4N  
 RANGE 6W

TOWN OF GLEN HAVEN

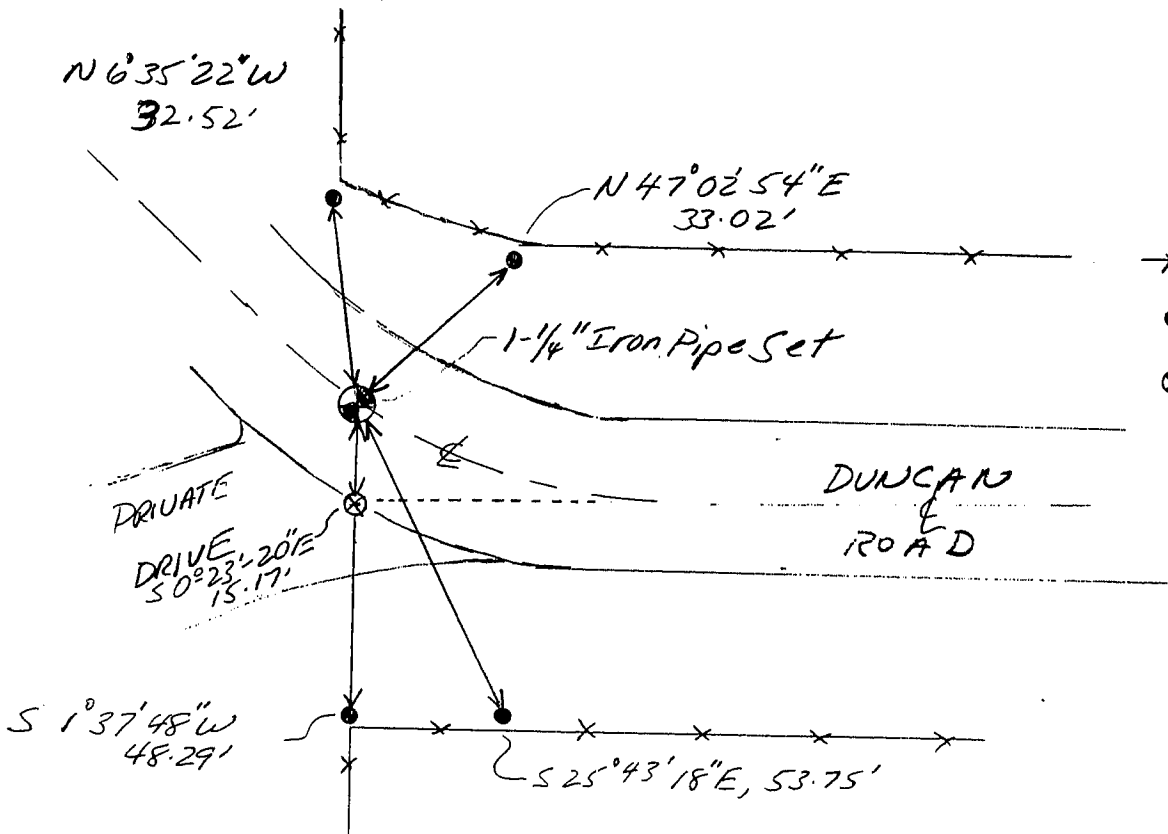
TIE SKETCH

There are no recent survey records of this corner. Survey records from the mid-1800's indicate the north line of the NW 1/4 to be longer than the North line of the NE 1/4. This was the way it was found in the field. Occupational evidence is a town road to the east and a fence line to the north and south. The fence line was accepted for the easting of the restored corner and fit well with the occupied 1/4 of the section. The northing was computed on a straight line between a post of record at the NW corner and the occupied NE corner. Relationships fit well with those in a survey dated 4/16/1855.

1" = 30'
