U.S. PUBLIC LAND SURVEY MONUMENT RECORD

T. 5 N. - R. 1 W
4 th Principal Meridian
Corner **125**

Northeast Corner of Section 3, Township 5 North, Range 1 West, Grant County, Wisconsin

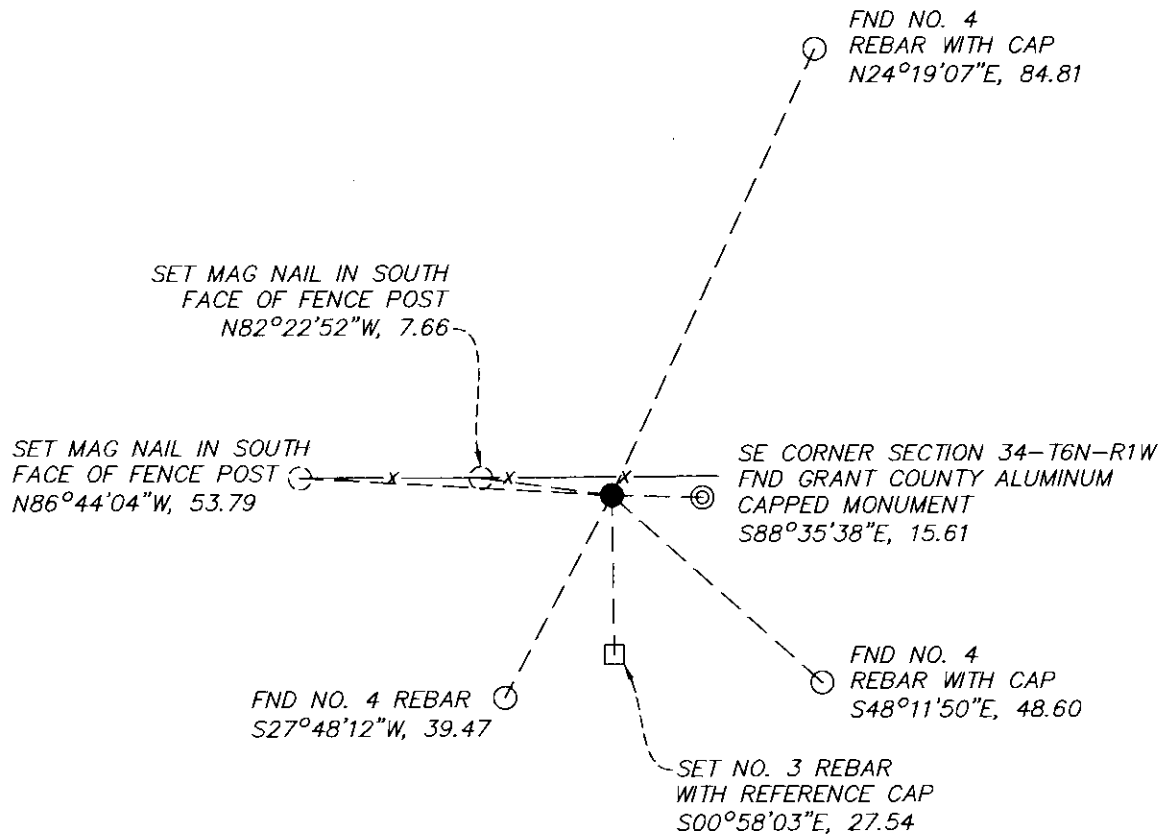
Location Diagram, showing corner identification name, bearing and distance references to at least four witness monuments, fence or occupational lines, centerlines of roads, and other site details for reference. Also, show the bearings and distances between the witness monuments.

- ⊙ FND GRANT COUNTY ALUMINUM CAPPED MONUMENT
- FND NO. 4 REBAR
- SET NO. 3 REBAR WITH REFERENCE CAP
- SET MAG NAIL
- SET 3/4" x 18" REBAR

3. Was the corner re-established through last corner proportionate methods? If so, show the method, including the directions and distances to other public land survey corners used as evidence or used in determining the corner location.
 1. Westwood Professional Services searched the area and found a 60d nail with ribbon near a planted shale stone. The a monument does not match the record monument of a 2" pipe, but fits the proportioned distance between the SE of Section 34 and S1/4 of Section 34 of T6N R1W. Found monument lands near the base of a newer fence post. Previous surveys in the NW1/4 of Section 2 have been inconstant with the existing corners, and unreliable. Replaced the 60d nail with a 3/4" x 18" rebar. This position agrees with the surrounding corners.
 2. B
 3. NO
