U.S. PUBLIC LAND SURVEY MONUMENT RECORD

T. 5 N. - R. 1 W
4th Principal Meridian
Corner **37**

East Quarter Section 9, Township 5 North, Range 1 West, Grant County, Wisconsin

EAST 1/4 CORNER
SECTION 9
TOWN 5 NORTH
RANGE 1 WEST
CLIFTON TOWNSHIP
GRANT COUNTY, WISCONSIN

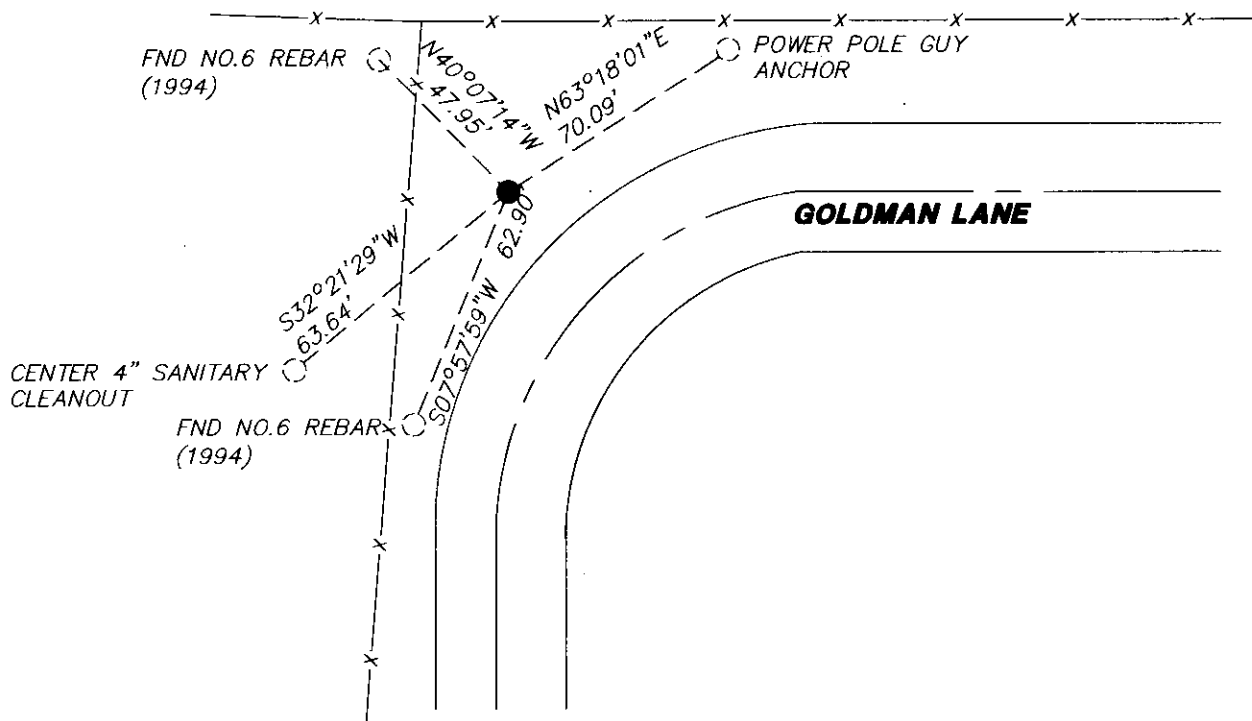
Location Diagram, showing corner identification name, bearing and distance references to at least four witness monuments, fence or occupational lines, centerlines of roads, and other site details for reference. Also, show the bearings and distances between the witness monuments.

- FND NO.6 REBAR
- FND NO.10 REBAR

3. Was the corner re-established through lost corner proportionate methods? If so, show the method, including the directions and distances to other public land survey corners used as evidence or used in determining the corner location.
 1. Westwood Professional Services searched the area and found the #10 rebar, 2 ties from 1994 certificate and set 2 ties.
 2. D
 3. NO

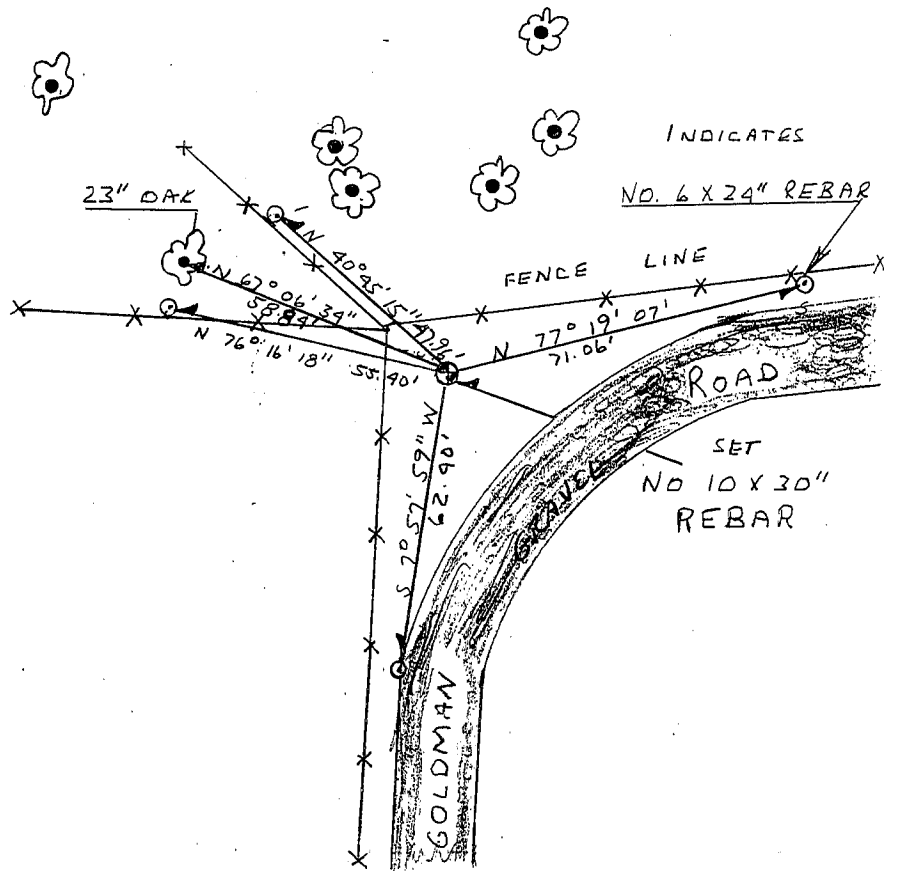
SCALE: 1" = 40'

NO 10x30" REBAR SET FROM EXISTING PHYSICAL EVIDENCE OF ROADS AND FENCES AFTER VERIFICATION BY PROPORTIONATE MEASURES FROM EDM TRAVERSE OF THE AREA.

(d) Show a plan view drawing depicting the relevant monuments and reference ties which is sufficient in detail to enable accurate relocation of the corner monument if the corner monument is disturbed. Indicate north.
