# U.S. PUBLIC LAND SURVEY MONUMENT RECORD

East 1/4 corner of Section 35, Town 5 North, Range 1 West, Clifton Township, Grant County, Wisconsin.

Survey Monument Record

CORNER NO. \_\_\_\_\_  
 SECTION 36  
 TOWN 5 NORTH  
 RANGE 1 WEST

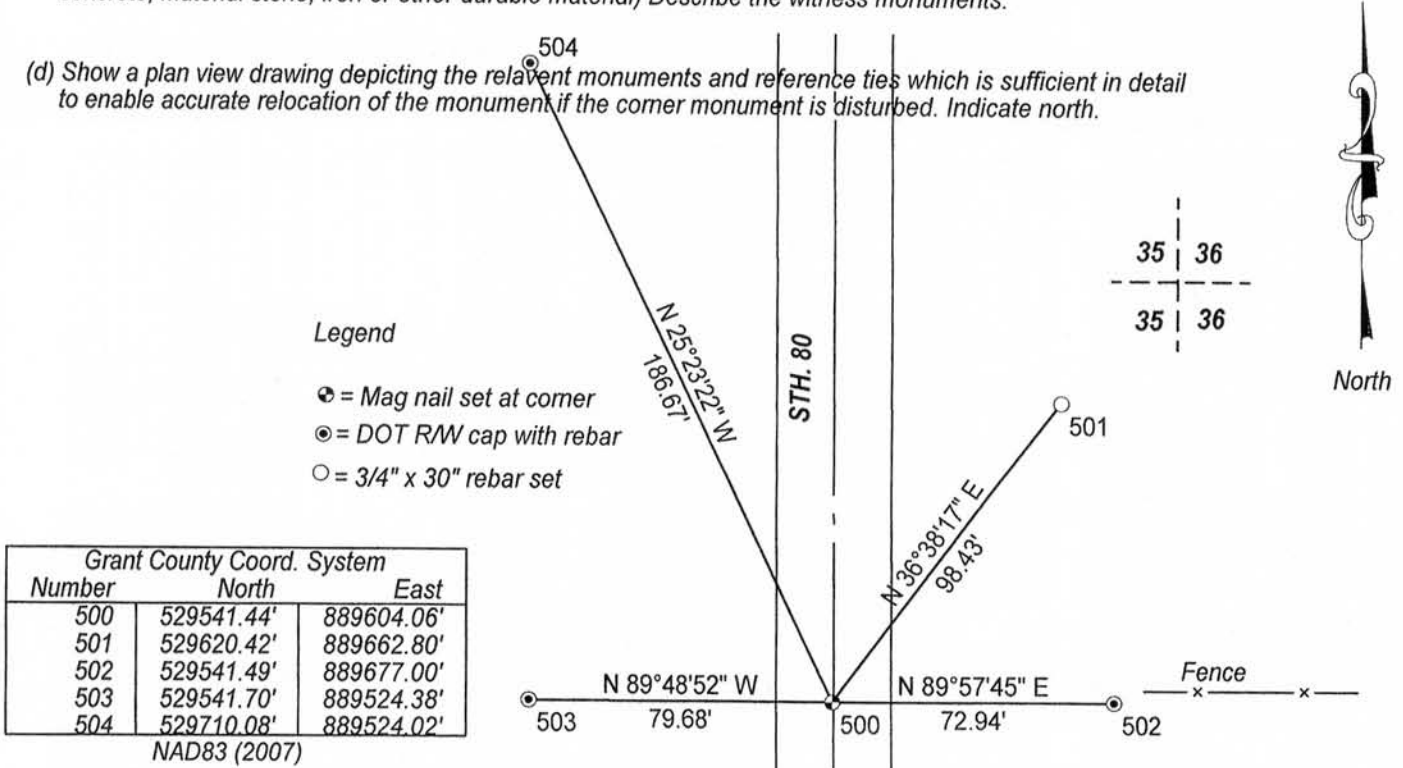
I found and accepted a P.K. nail with a shiner. The P.K. nail was consistent with the location described in WIDOT Project Plat # 5035-00-21. After road construction, I reset the corner as shown below.

(c) In the plan view below, provide reference ties to at least 4 witness monuments. (Witness monuments shall be made of concrete, material stone, iron or other durable material) Describe the witness monuments.

(d) Show a plan view drawing depicting the relevant monuments and reference ties which is sufficient in detail to enable accurate relocation of the monument if the corner monument is disturbed. Indicate north.

(2) Acceptance of a found perpetuated location.

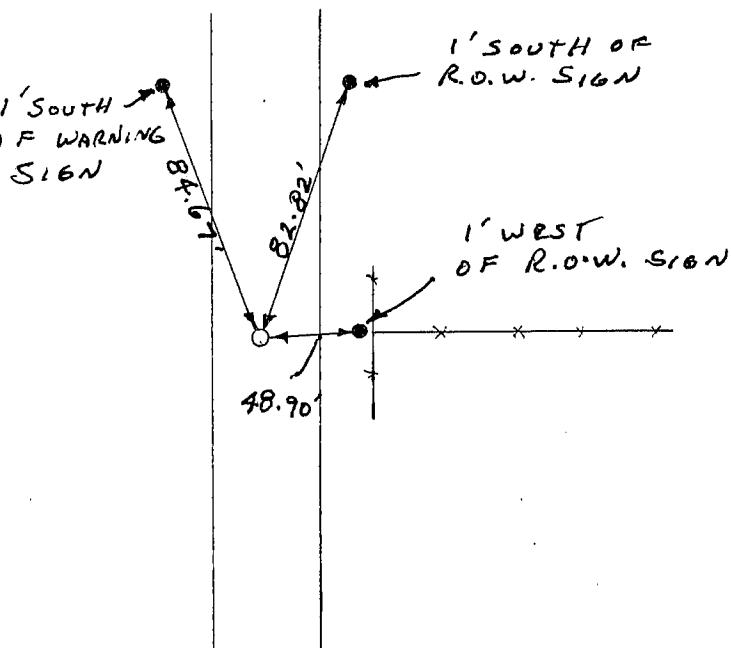
TIE SKETCH

I FOUND NO HISTORY OF THIS CORNER SINCE THE ORIGINAL GOVERNMENT SURVEY. I SET THIS CORNER BY HOLDING THE ESTABLISHED EAST 1/4 CORNER AND USING THE OCCUPIED EAST - WEST 1/4 LINE AND THE FORTY CORNERS. I PRORATED FROM EAST TO WEST.

Show at least three (3) ties and monument
