U.S. PUBLIC LAND SURVEY MONUMENT RECORD - GRANT COUNTY, WI
 Section 14, Town 5 North Range 5 West, Town of Patch Grove

U. S. PUBLIC LAND SURVEY MONUMENT RECORD

NE CORNER, SEC 14
T5N, R5W, GRANT CO.,
WISC.

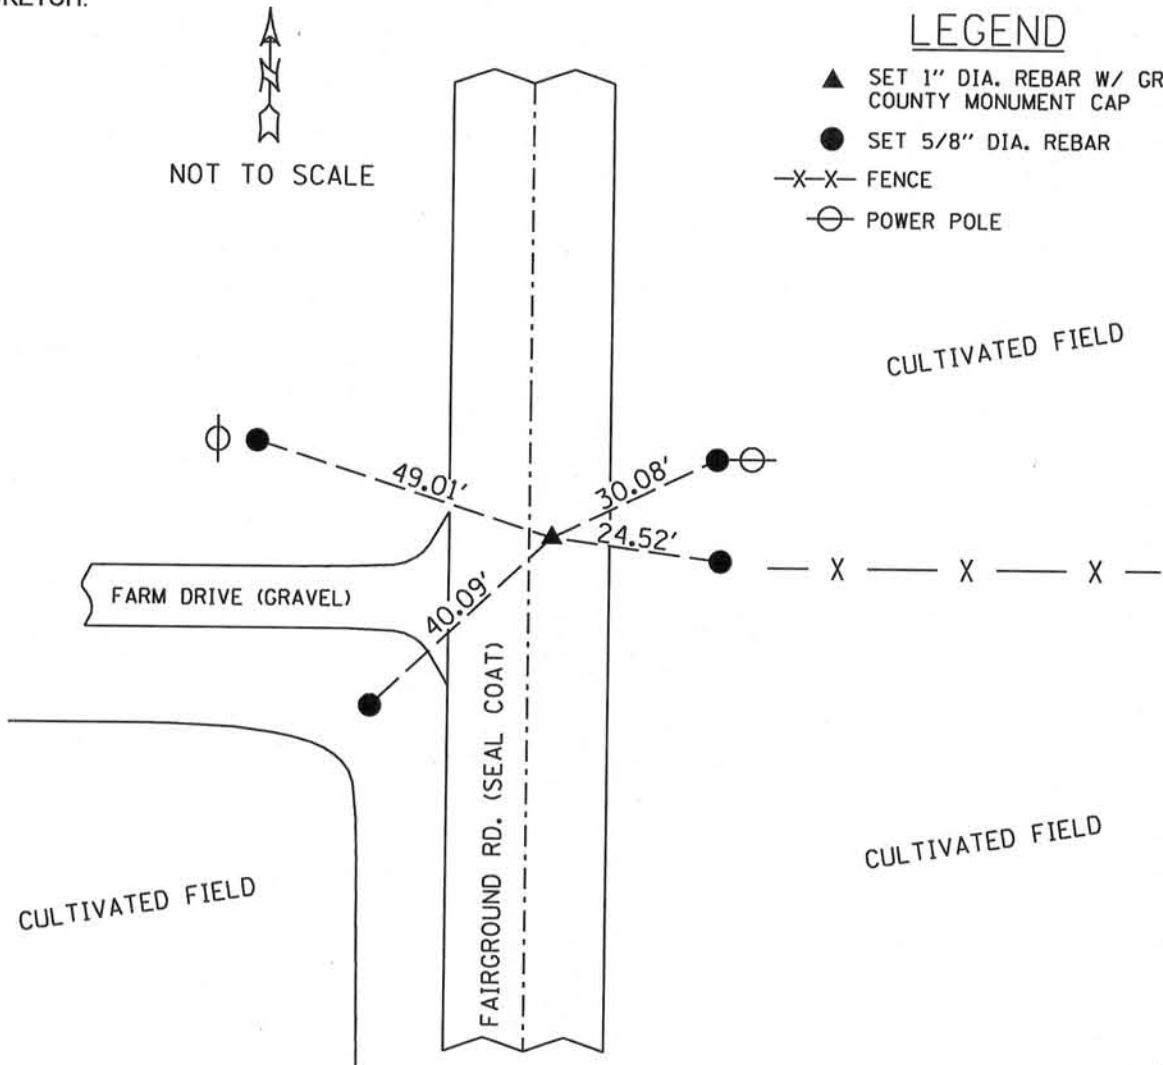
SKETCH:

DESCRIPTION OF CORNER EVIDENCE FOUND: CORNER AND ACCESSORIES HAVE BEEN OBLITERATED. RE-ESTABLISHED CORNER LOCATION USING PREVIOUS PLAT OF SURVEY BY LARRY AUSTIN IN 1988.

DESCRIPTION OF CORNER AND WITNESS MONUMENTS, references and accessories used to perpetuate the original or re-established location of this corner.

- ▲ SET 1" DIA. REBAR W/ GRANT COUNTY MONUMENT CAP
- SET 5/8" DIA. REBAR
- X-X- FENCE
- ⊕ POWER POLE

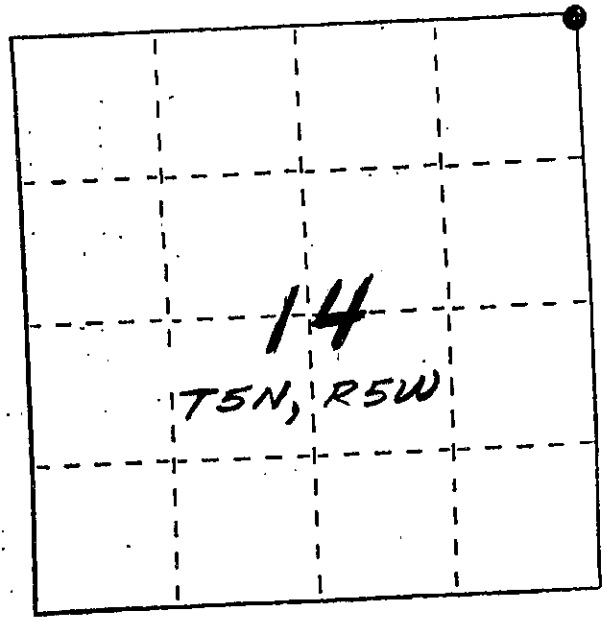
NO RECORD SINCE ORIG SURVEYS; MONUMENT PLACED
BASED ON OCCUPATIONAL EVIDENCE, VERIFIED BY AN
EDM TRAVERSE OF THE AREA.

- (d) Show a plan view drawing depicting the relevant monuments and reference ties which is sufficient in detail to enable accurate relocation of the corner monument if the corner monument is disturbed. Indicate north.

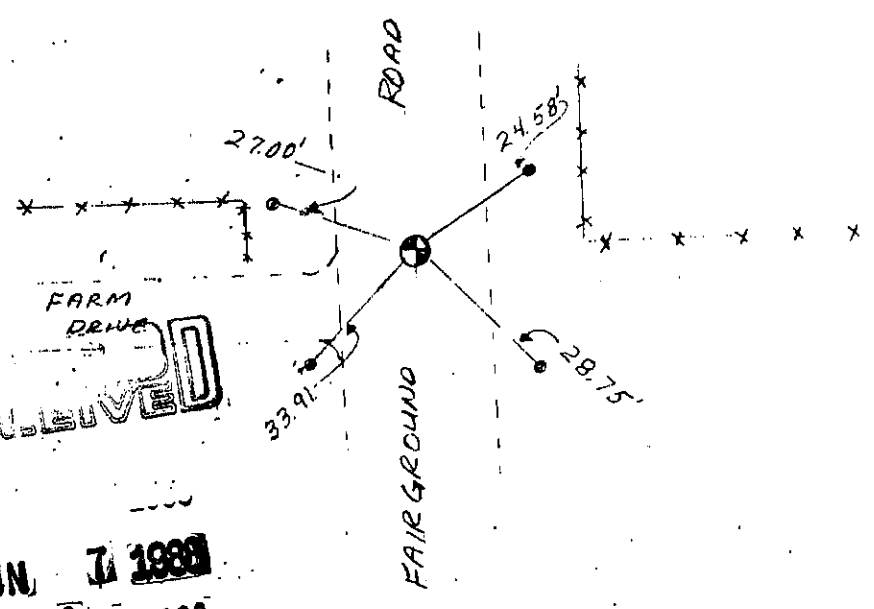
- 1" x 24" REBAR
- 1/2" x 24" REBAR
- *-*-* FENCE LINE
- NO SCALE
