U.S. PUBLIC LAND SURVEY MONUMENT RECORD

T. 6 N. - R. 1 W  
4<sup>th</sup> Principal Meridian  
Corner **69**

Northeast Corner Section 20, Township 6 North, Range 1 West, Grant County, Wisconsin

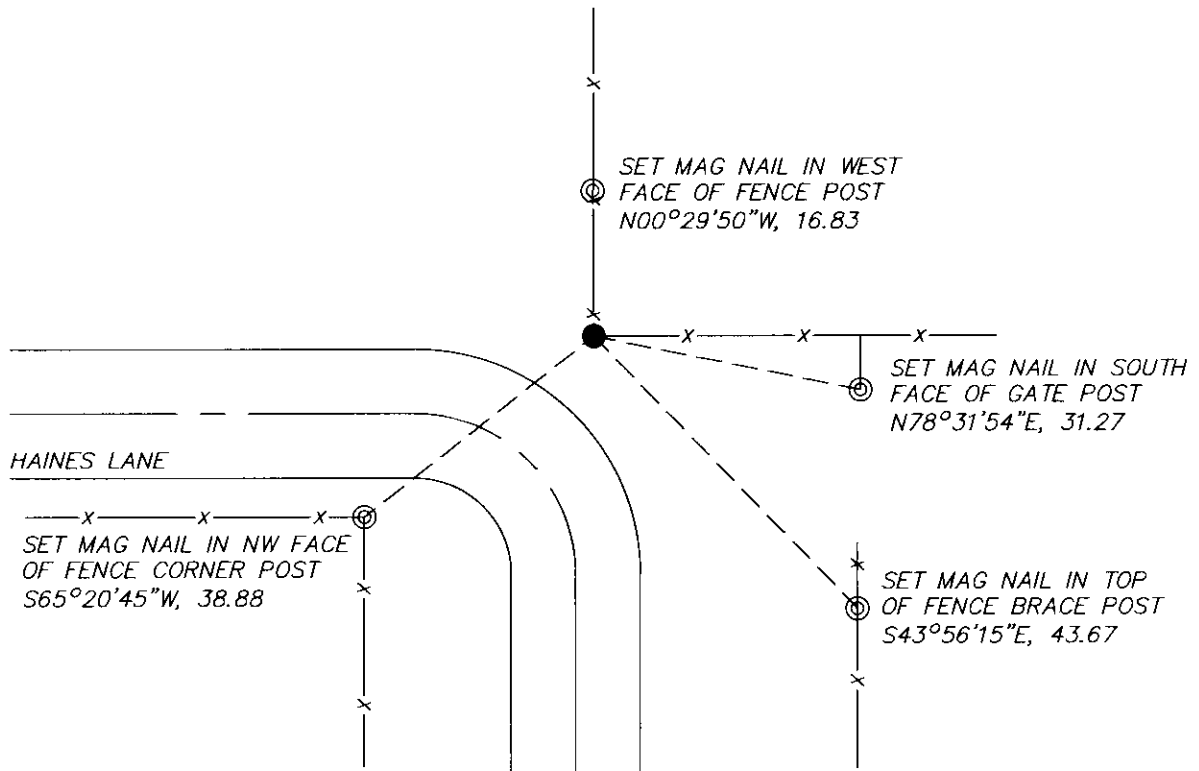
- ⊙ SET MAG NAIL
- SET NO. 6 REBAR, 18" LONG, AT BASE OF FENCE CORNER POST

3. Was the corner re-established through lost corner proportionate methods? If so, show the method, including the directions and distances to other public land survey corners used as evidence or used in determining the corner location.
  1. Westwood Professional Services searched the area and found no monument. No other evidence of the corner position was found while conducting research. There is a fence line in the area that runs North and East. This fence corner fits GLO distances within reason. Holding the fence corner for the N/E fence line as the best available evidence of the corner. Set a 3/4" x 18" rebar at the base of the corner post as the corner position and set 4 ties.
  2. B
  3. NO
