U.S. PUBLIC LAND SURVEY MONUMENT RECORD

T. 6 N. - R. 1 W.
4 th Principal Meridian
Corner **81**

Northeast Corner Section 25, Township 6 North, Range 1 West, Grant County, Wisconsin

The Southeast Corner of Section 24, Town 6 North, Range 1 West, Wingville Township, Grant County, Wisconsin.

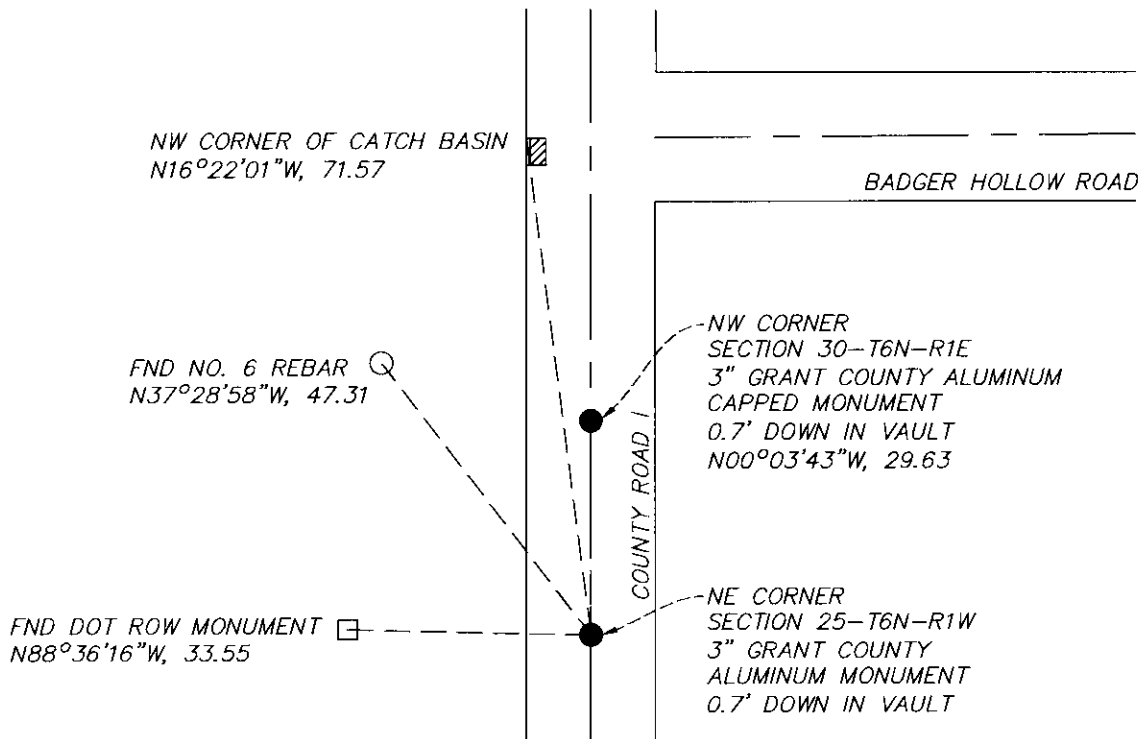
- FND DOT ROW MONUMENT
- FND NO. 6 REBAR
- CATCH BASIN
- FND 3" GRANT COUNTY ALUMINUM CAPPED MONUMENT

3. Was the corner re-established through lost corner proportionate methods? If so, show the method, including the directions and distances to other public land survey corners used as evidence or used in determining the corner location.
 1. Westwood Professional Services searched the area and found a bar with 3" Grant County Aluminum cap, 2 of 5 ties per 1998 cert, and measured 29.63' to NW30-6N-1E. Accepting as corner location.
 2. D
 3. NO
