U.S. PUBLIC LAND SURVEY MONUMENT RECORD - GRANT COUNTY, WI

Section 19, Town 7 North Range 2 West, Town of Hickory Grove (a)

SW CORNER T7N R2W

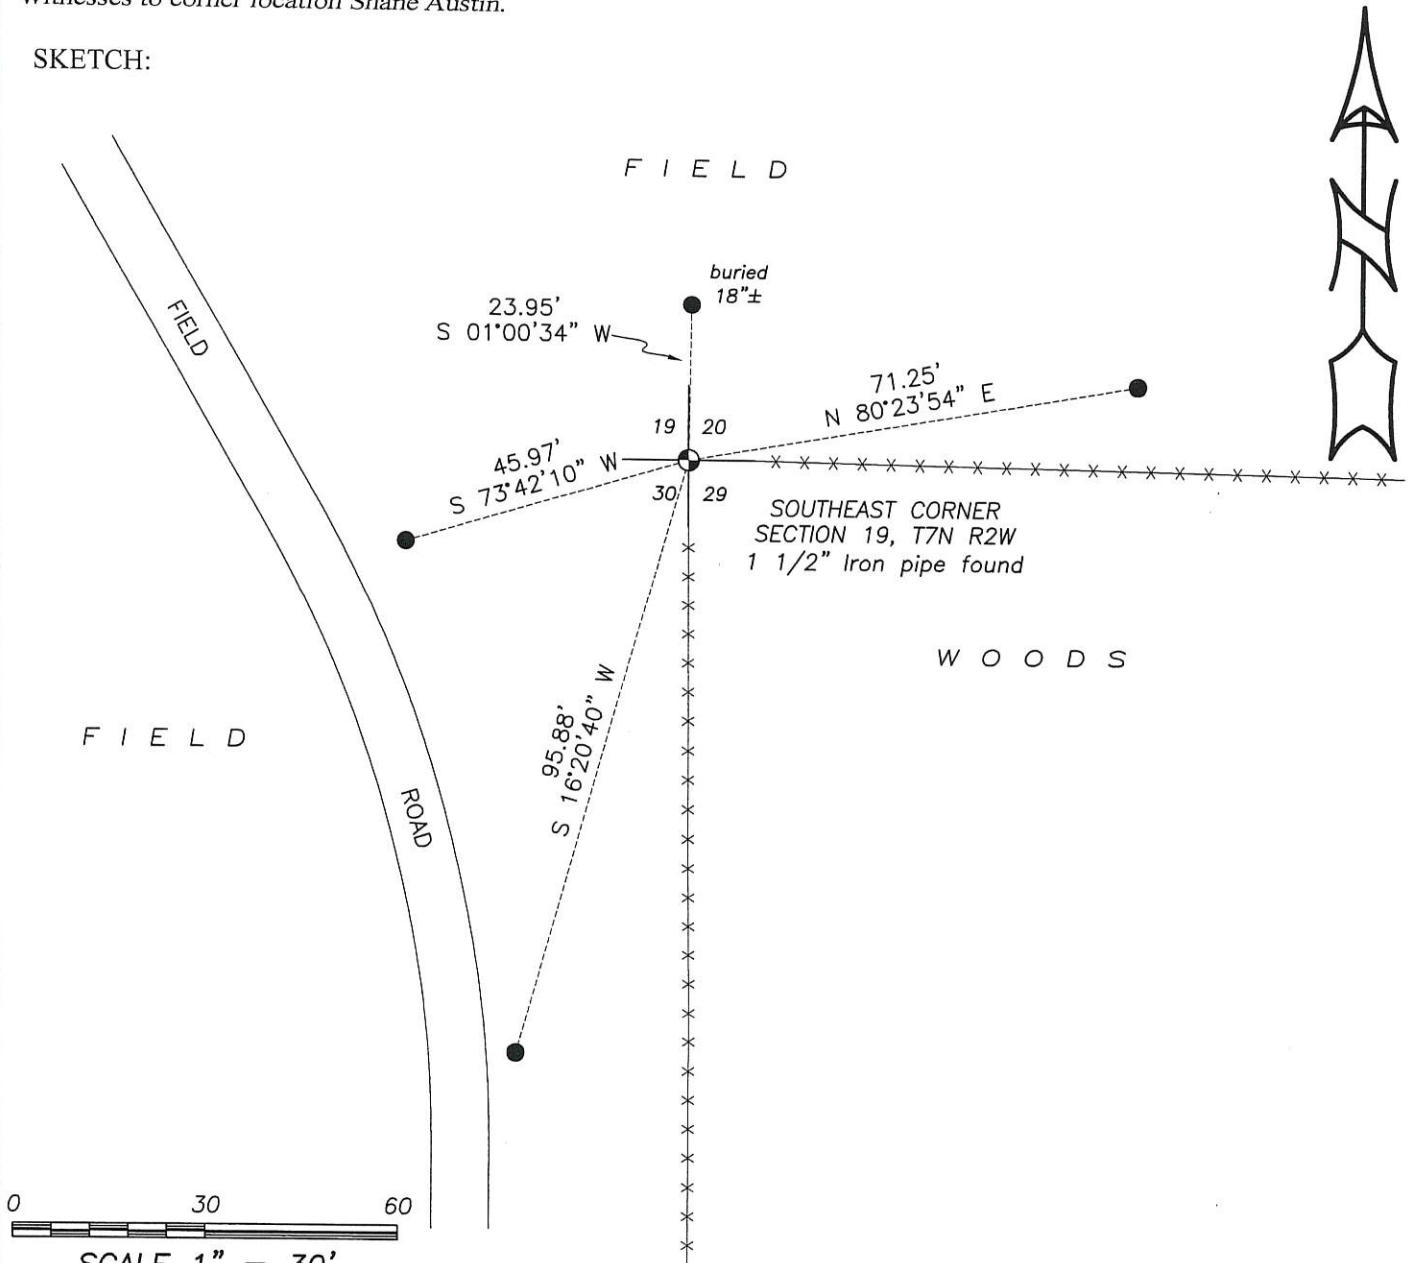
SKETCH:

I found the 1 1/2" iron pipe as established by Laurence Schmit. I set four new witness corners after I verified the corner's location with G.P.S. and E.D.M. methods

DESCRIPTION OF CORNER AND WITNESS MONUMENTS, references and accessories used to perpetuate the original or re-established location of this corner. (c) (d) (e)
 Witnesses to corner location Shane Austin.

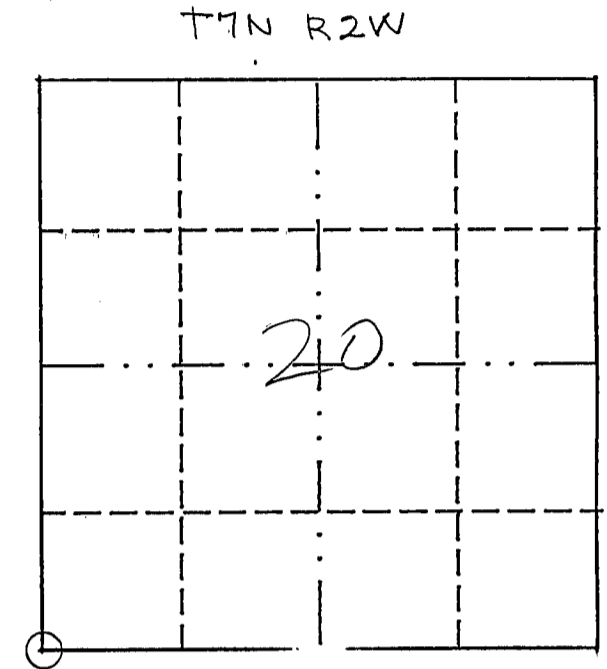
○ = corner monument restored.

NO MONUMENT EVIDENCE. OCCUPATIONAL EVIDENCE TO OLD FENCE LINE INTERSECTION WITH FENCE LINE S & E. MONUMENT WAS PLACED AFTER EDM TRAVERSE OF ~~THE~~ LINE OF SECTION 20.

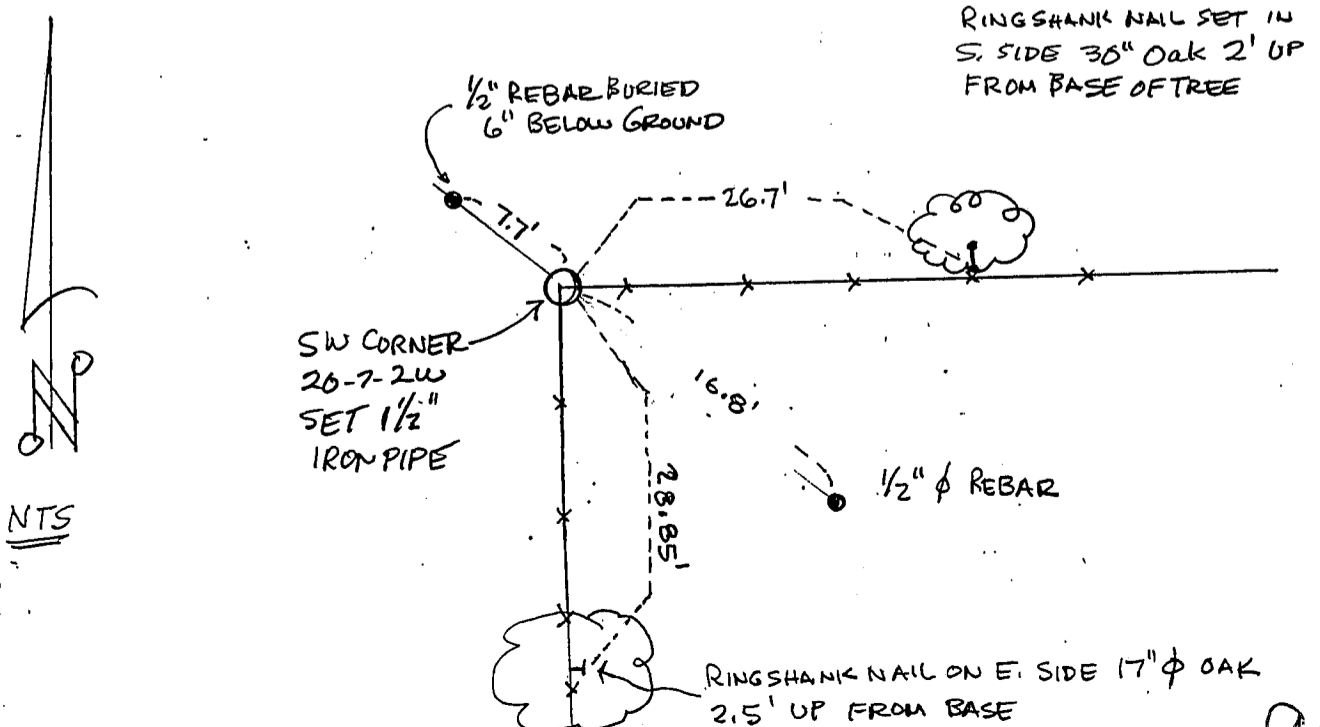
(d) Show a plan view drawing depicting the relevant monuments and reference ties which is sufficient in detail to enable accurate relocation of the corner monument if the corner monument is disturbed. Indicate north.
