Sec. 21, T5N, R3W

U. S. PUBLIC LAND SURVEY MONUMENT RECORD

N $\frac{1}{4}$ corner of Section 21, T5N, R3W

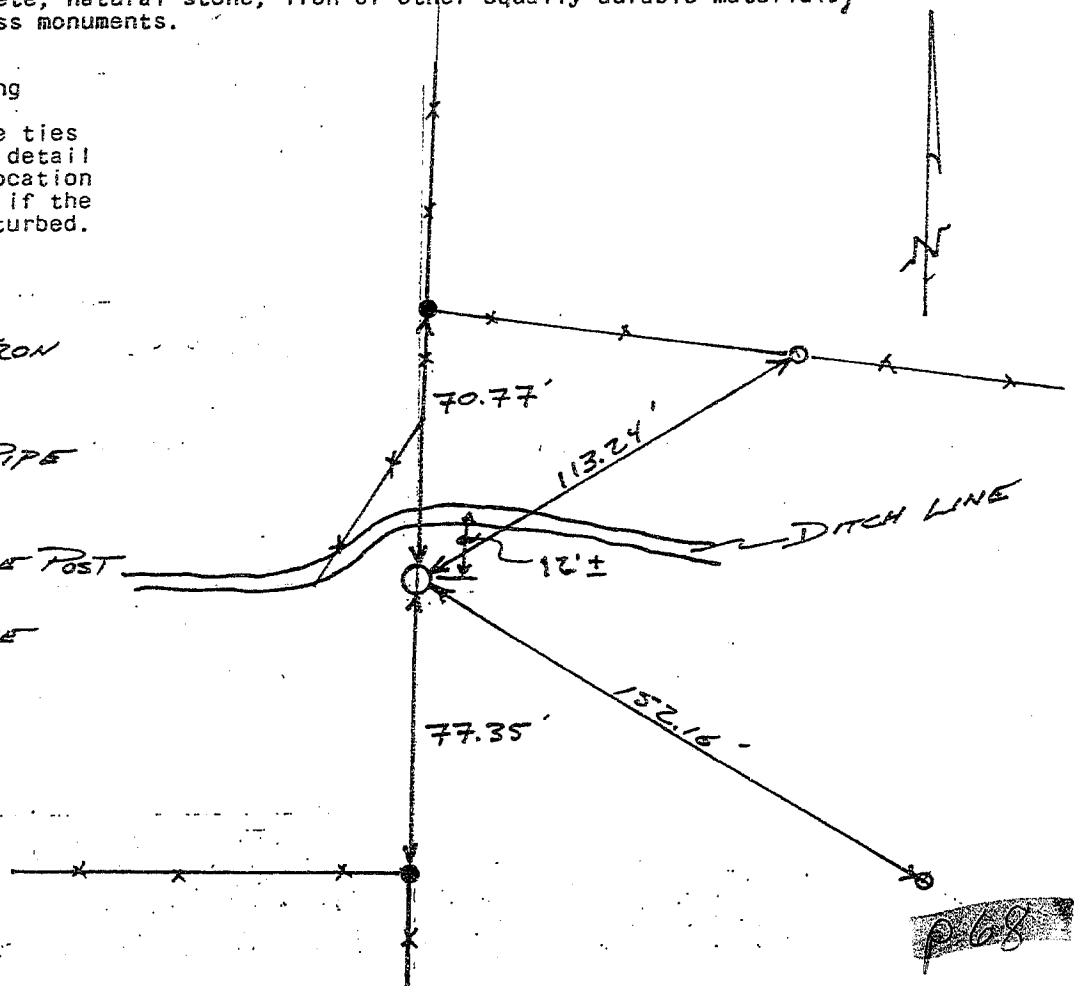
Placed corner at the intersection of an extension of the fences from the south and west. This checked good with other fences to the East and West.

- (d) Show a plan view drawing depicting the relevant monuments and reference ties which is sufficient in detail to enable accurate relocation of the corner monument if the corner monument is disturbed. Indicate north.
