U.S. PUBLIC LAND SURVEY MONUMENT RECORD - GRANT COUNTY, WI

Section 24, Town 5 North Range 5 West, Town of Bloomington East

The Southwest Corner of
Section 24, Town 5 North,
Range 5 West, Bloomington
Township, Grant County,
Wisconsin.

NW corner section 25
T5N R5W of the
4th P.M.
Town of Bloomington
Grant County, Wisconsin

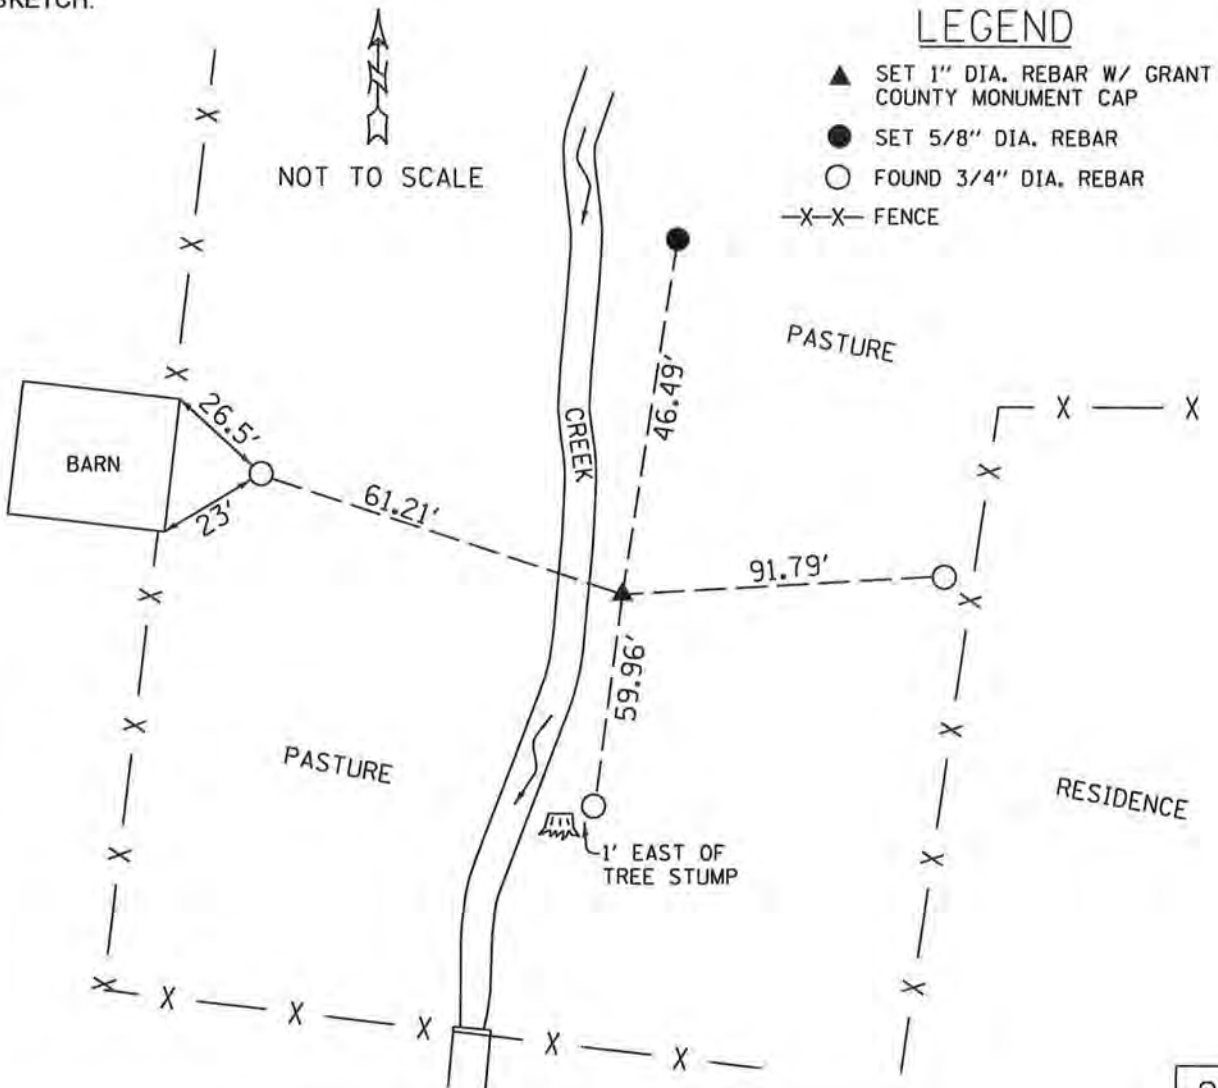
SKETCH:

HISTORY OF CORNER ESTABLISHMENT: A 5"x5"x30" CONCRETE MONUMENT WAS REPLACED BY A DOT ALUMINUM CAP SET IN A ROCK OUTCROP IN 1988.

DESCRIPTION OF CORNER EVIDENCE FOUND: THE DOT CAP WAS NOT FOUND. THREE OF THE FOUR ACCESSORY MONUMENTS WERE FOUND AND A 1" DIAMETER REBAR W/ GRANT COUNTY CAP WAS SET AS SHOWN.

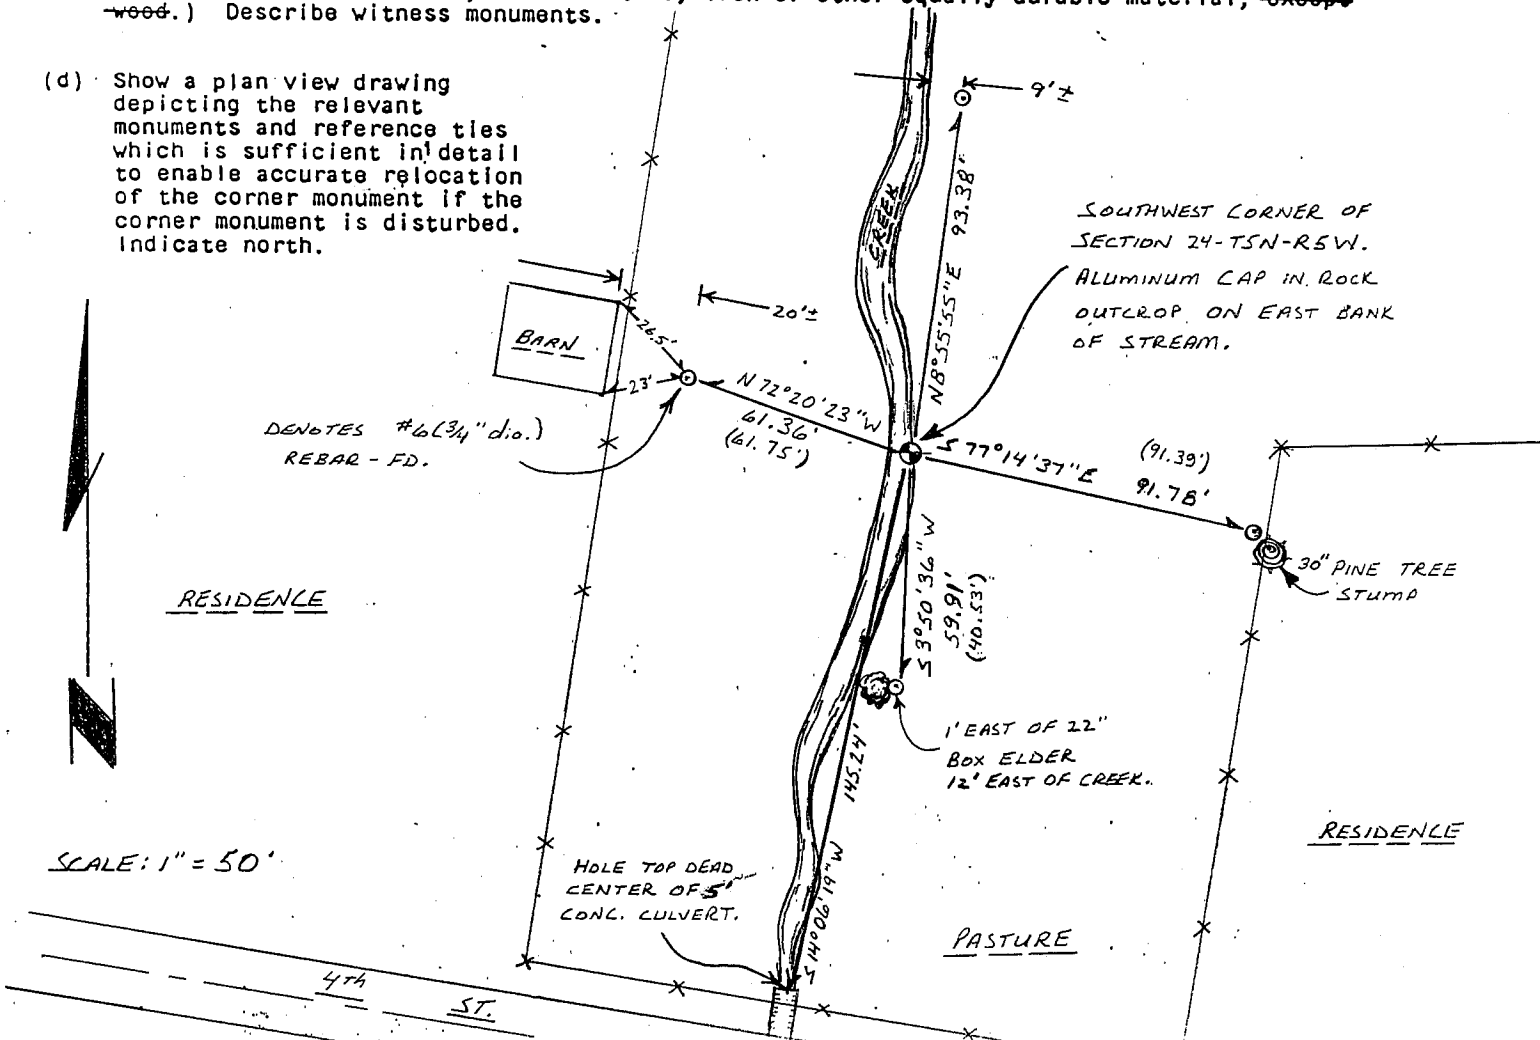
SCALE: 1" = 50'

A D.O.T. Aluminum cap set in a rock outcrop was found and accepted as shown on a previous tie sheet of record.

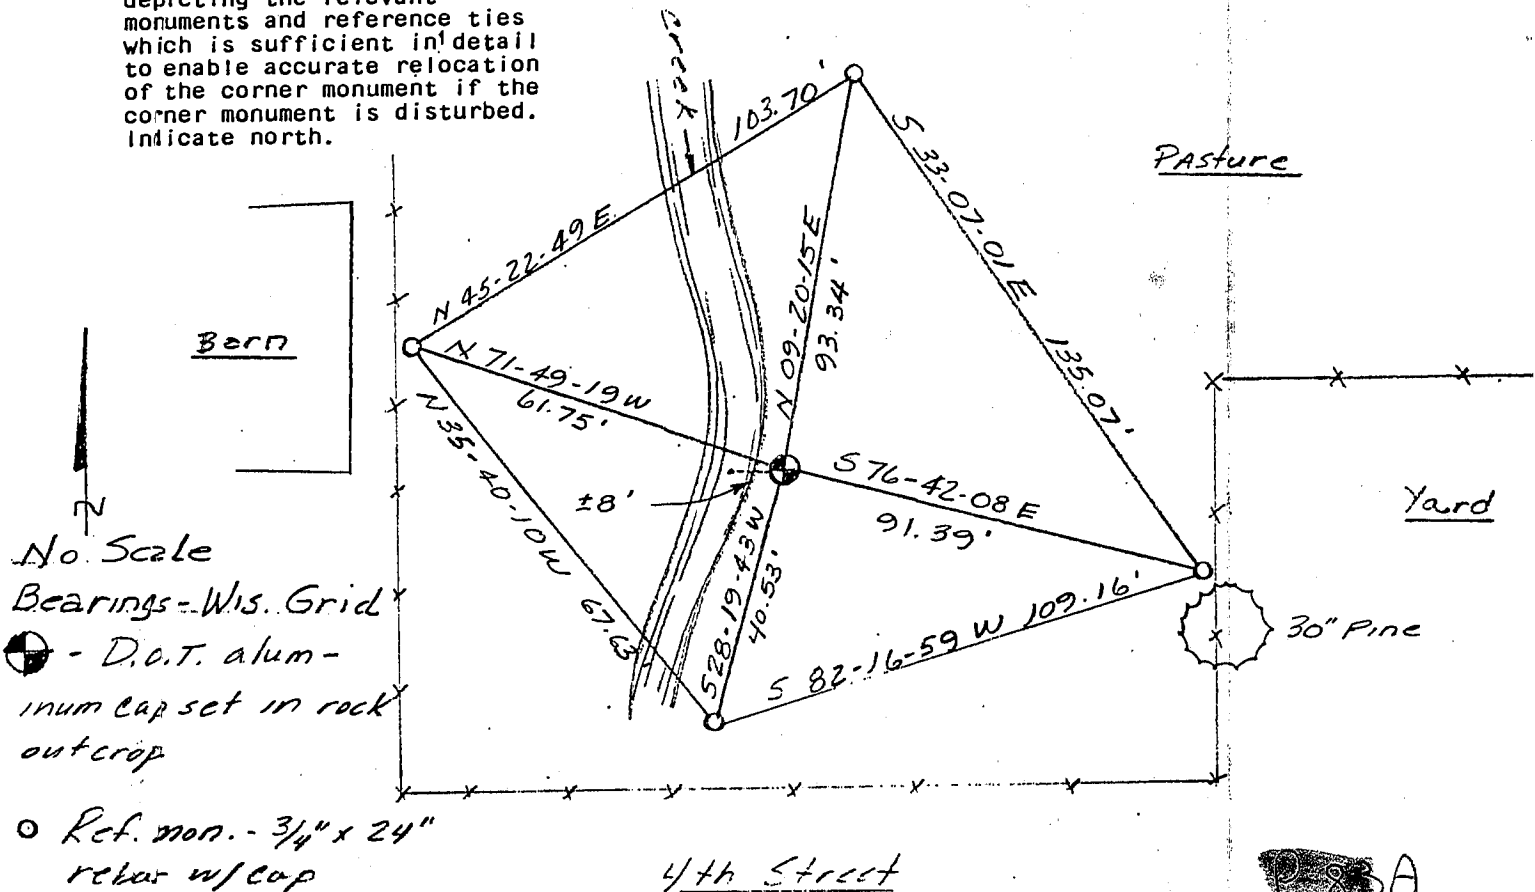
Monument Set replaces a 5" x 5" x 30" concrete monument. This concrete monument had been accepted as the section corner. The monument is referred to in the Assessors Plat No. 1 to the Village of Bloomington and a 1977 Survey by Laurence E Schmit. The concrete monument was replaced because it was being eroded into the creek and it was unstable as it was.

No Scale
Bearings - Wis. Grid
● - D.O.T. aluminum cap set in rock outcrop
○ Ref. mon. - 3/4" x 24" rebar w/cap
