# GRANT COUNTY CERTIFIED U.S. PUBLIC LAND SURVEY MONUMENT RECORD

CORNER NO. 87(W)

Northwest corner of Section 27, T6N, R1W, Town of Wingville, Grant County, Wisconsin.

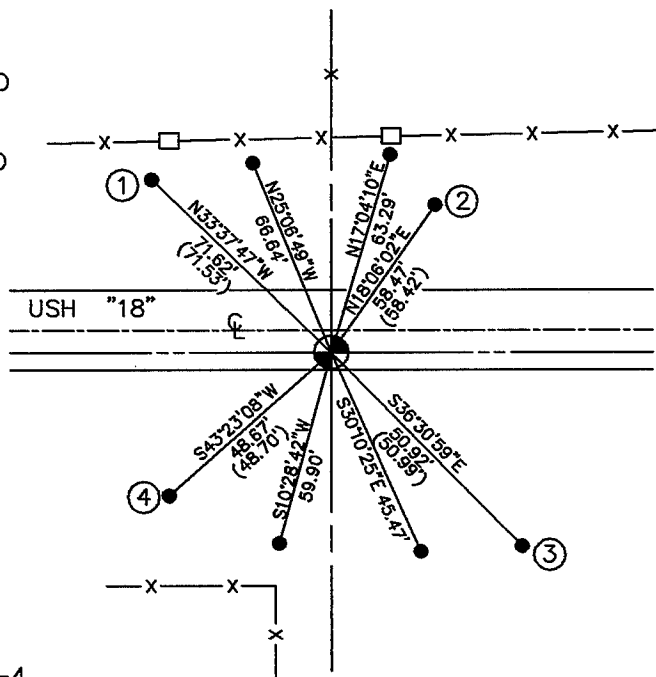
THE ALUMINUM MONUMENT SHOWN ON THE 1989 TIE SHEET BY ROSS MICHAELS IS STILL IN PLACE, BUT IS NOW COVERED BY 8" OF NEW ASPHALT. I PLACED A COTTON GIN SPIKE IN THE ASPHALT DIRECTLY OVER THE BURIED MONUMENT.

TIE DISTANCES MEASURED HORIZONTALLY BY E.D.M.

NOTE: TIES LABELED 1-4 ARE ORIGINAL TIES SHOWN MICHAELS 1989 TIE SHEET.

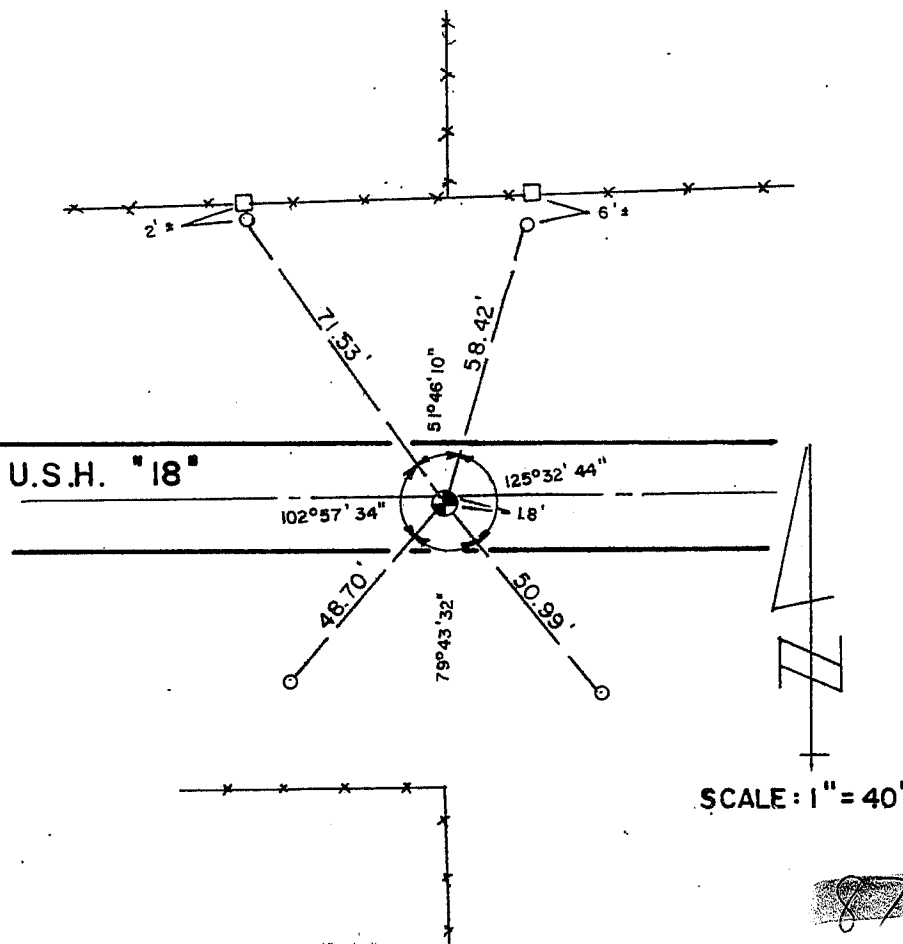
87

I set the aluminum monument at the Northwest corner of Section 27, T6N, R1W on the occupied North-South fenceline (extended) midway between the West 1/4 corner of Section 27 and the occupied fence corner at the West 1/4 corner of Section 22.

- WOOD POST
- 3/4" x 24" REBAR SET
- ⊙ CAST ALUMINUM MONUMENT SET

SCALE: 1" = 40'
