U. S. PUBLIC LAND SURVEY MONUMENT RECORD

The Southeast Corner of Section 24, Town 6 North, Range 1 West, Wingville Township, Grant County, Wisconsin.

Survey Monument Record

The Southwest Corner of Section 19,
Town 6 North - Range 1 East,
Eden Township, Iowa County,
Wisconsin.

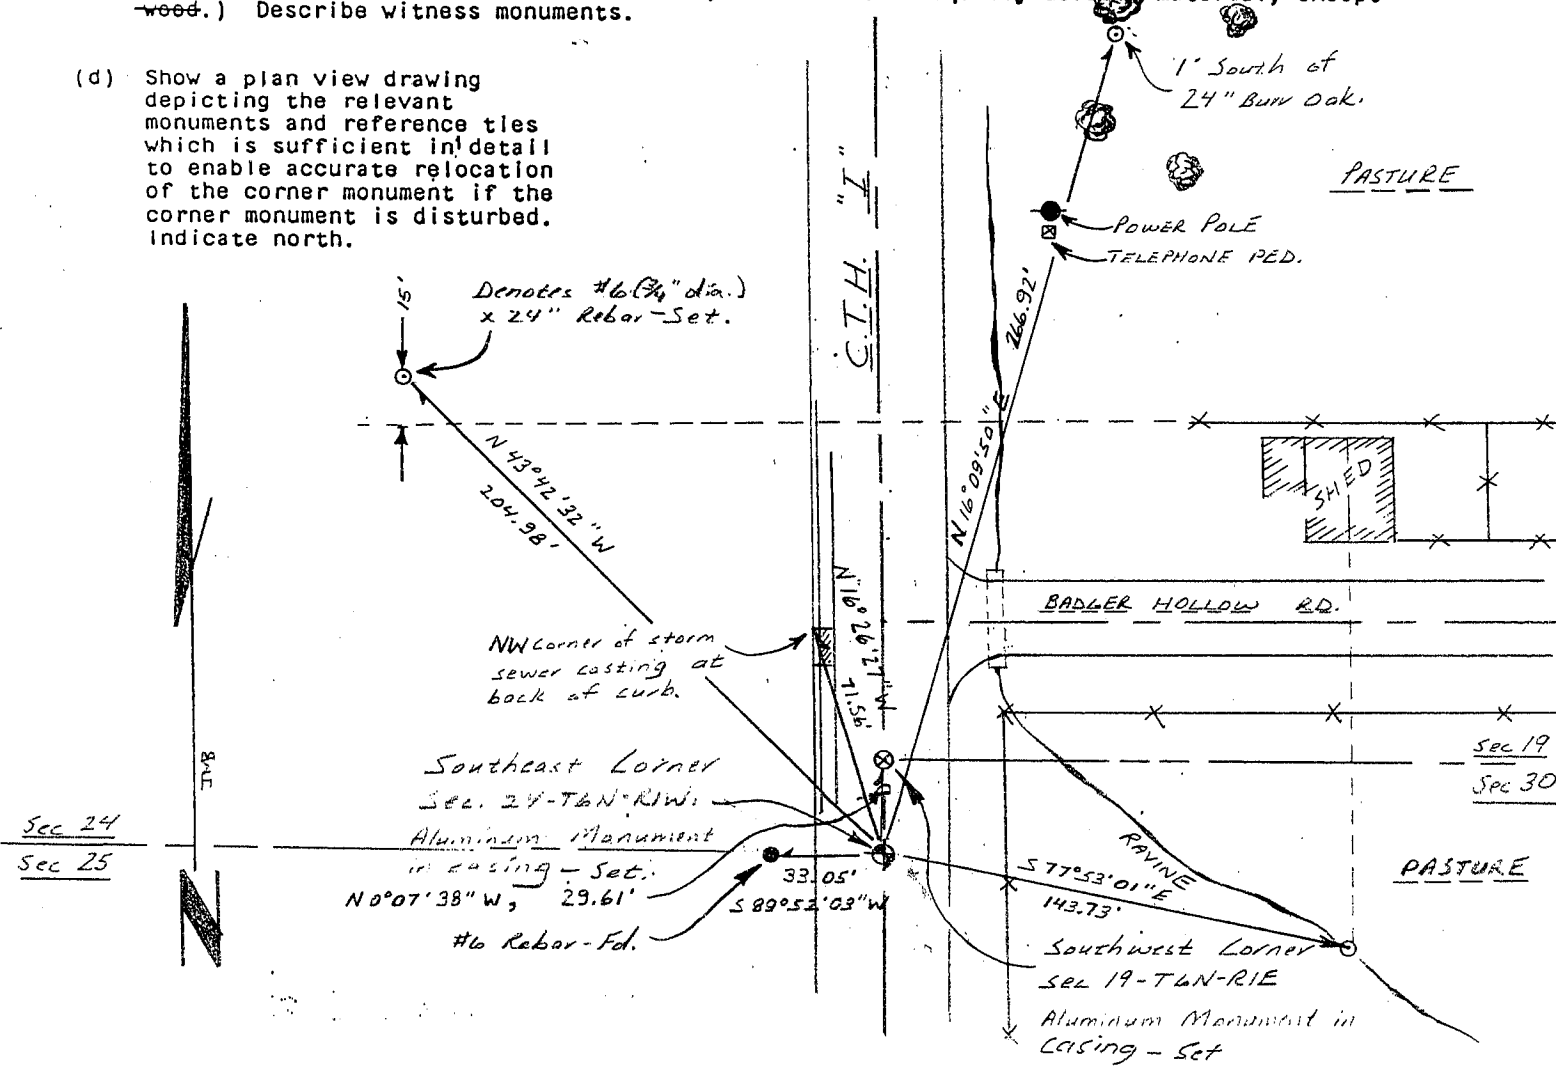
A #10 (1 1/4") Rebar was found and accepted. Set reference ties to replace position after road construction was completed in the area.

- (d) Show a plan view drawing depicting the relevant monuments and reference ties which is sufficient in detail to enable accurate relocation of the corner monument if the corner monument is disturbed. Indicate north.

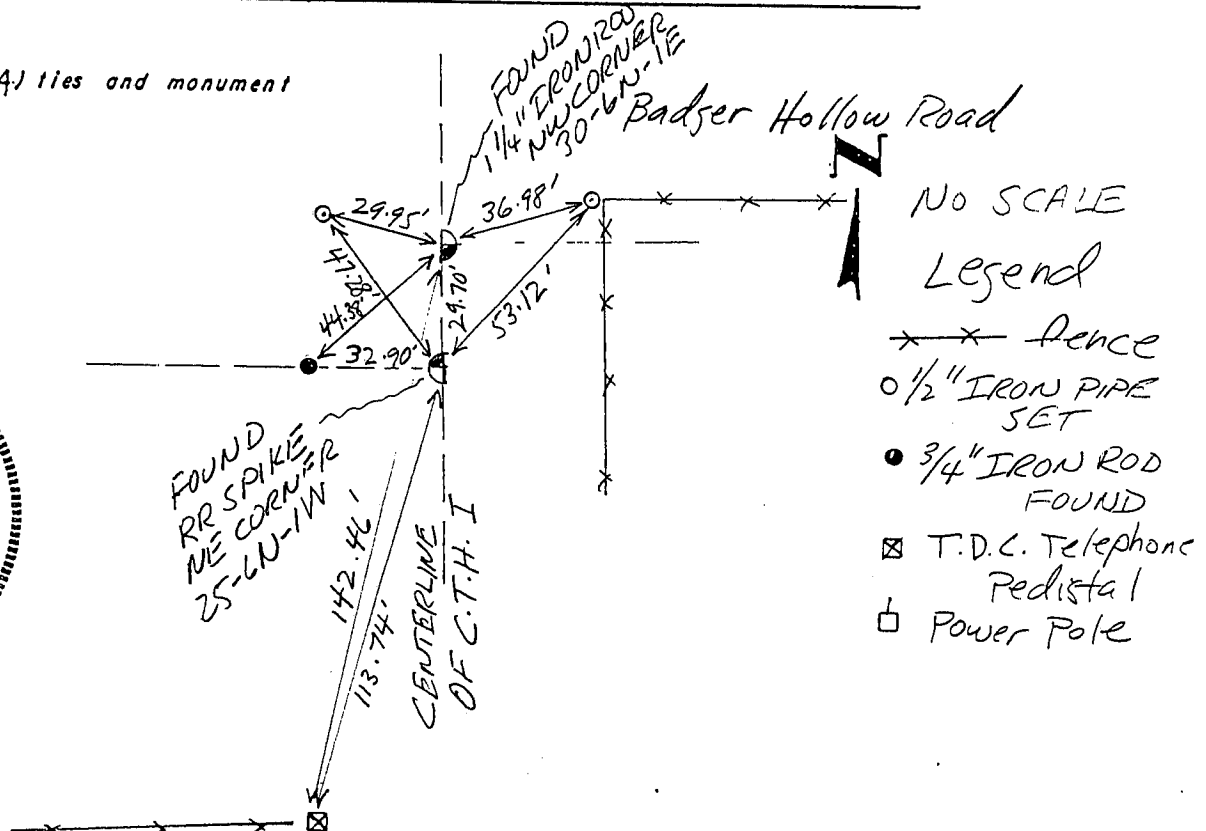
TIE SKETCH

A RR spike was found in place as noted in many area surveys, recorded and unrecorded, at the NE corner of 25-6N-1W. A 1 1/4" Iron Rod was found at the original corner offset north of this spike on the Meridian. The RR spike at the NE of 25-6N-1W is balanced with occupation at the E 1/4 of 24-6N-1W and an existing monument at the E 1/4 of 25-6N-1W 2649.41' x 2648.39' respectively and also fits record to the original plat of Montfort to the west. Correlation of other corners north and east side of the meridian is poor with the original govt. record hence, the found Iron Rod was accepted at the record call.

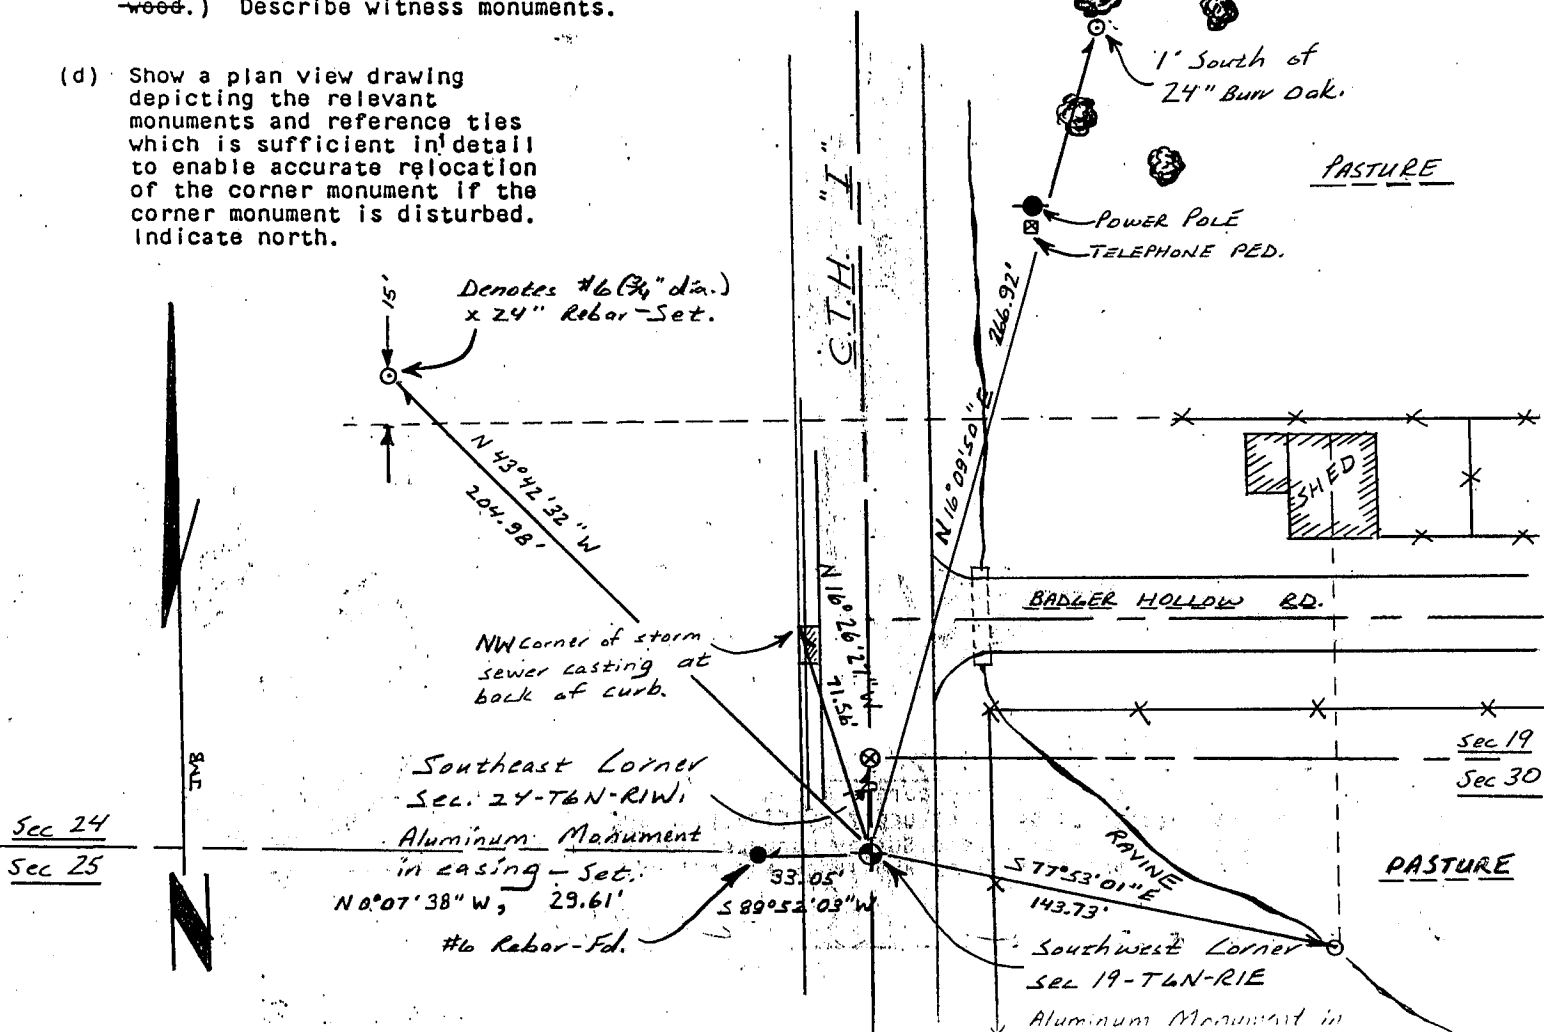
A #10 (1 1/4") Rebar was found and accepted. Set reference ties to replace position after road construction was completed in the area.

- (d) Show a plan view drawing depicting the relevant monuments and reference ties which is sufficient in detail to enable accurate relocation of the corner monument if the corner monument is disturbed. Indicate north.
