U.S. PUBLIC LAND SURVEY MONUMENT RECORD

The E 1/4
corner of Section 15

T. 6 N., R. 2 W
Grant County, Wisconsin

Job ID: 2005-51

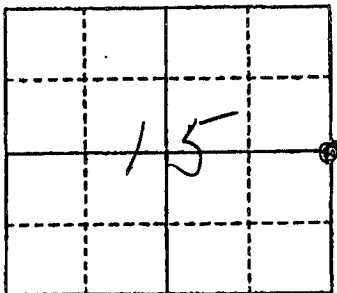
Describe the monument and accessories used to perpetuate the location of this corner. (Include a plan view drawing and indicate what was set and/or found)

Set 1" Iron Rod w/ Alum. CAP 3" Below Grade

Tormey Road

Grant Co. Coord Sys.

History of original corner establishment and subsequent restorations and description of any record, monument, occupational, testimonial or other evidence considered: *There are no recent records of this corner. Ownership records indicate continuous change of ownership at the corner since the first conveyance. I accepted the occupied location of N-S road and fences East & West after a traverse of the section. I set a 1" Iron Rod with County Aluminium Cap at this location.*
