CERTIFIED U.S. PUBLIC LAND SURVEY MONUMENT RECORD

THE CENTER OF SECTION 20, TOWN 6 NORTH,
RANGE 2 WEST, TOWN OF FENNIMORE, GRANT
COUNTY, WISCONSIN.

GRANT COUNTY CORNER NO. 75A

U. S. PUBLIC LAND SURVEY MONUMENT RECORD

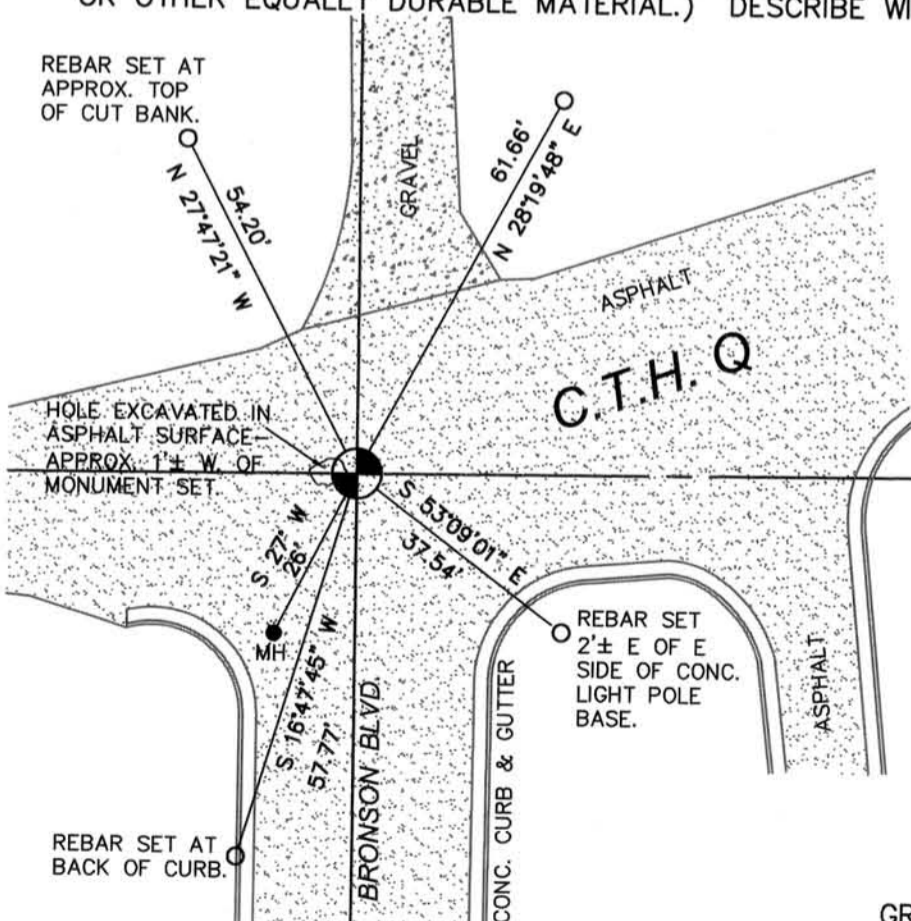
I FOUND A BADLY BENT AND TWISTED 3/4" DIAMETER REBAR BURIED UNDER THE ASPHALT OF C.T.H. Q. I EXCAVATED DOWN ABOUT A 14" AND TRIED TO EXTRACT THE REBAR, BUT COULD NOT REMOVE IT. EXCAVATING DEEPER WOULD HAVE REQUIRED OPENING UP A VERY LARGE HOLE IN THE NEWER ASPHALT OF C.T.H. Q, SO I LEFT THE REBAR IN PLACE. THE REBAR IS BENT VERY BADLY TO THE WEST AND ALSO APPEARS TO HAVE BEEN DISPLACED TO THE WEST, PROBABLY DUE TO THE RECONSTRUCTION OF C.T.H. Q SEVERAL YEARS AGO. I DROVE A 3/4" DIAMETER REBAR WITH GRANT COUNTY ALUMINUM CAP AT THE INTERSECTION OF THE QUARTER LINES, WHICH IS THE SAME METHOD BRUCE O. FRUDDEN, RLS, USED TO ESTABLISH THE LOCATION AS SHOWN ON HIS TIE SHEET DATED NOVEMBER 29, 1989. FRUDDEN'S TIES HAVE ALSO BEEN DESTROYED, SO I ESTABLISHED NEW ONES AS SHOWN BELOW.

(C) IN THE PLAN VIEW DRAWING BELOW, PROVIDE REFERENCE TIES TO AT LEAST 4 WITNESS
MONUMENTS OR, IF THE LOCATION IS WITHIN A MUNICIPALITY, TO AT LEAST 2 WITNESS
MONUMENTS. (WITNESS MONUMENTS SHALL BE MADE ON CONCRETE, NATURAL STONE, IRON,
OR OTHER EQUALLY DURABLE MATERIAL.) DESCRIBE WITNESS MONUMENTS.

- C1/4 COR. SECTION 20
3/4" Ø X 24" LONG REBAR W/
GRANT CO. ALUMINUM CAP-SET
- SET 3/4" Ø X 24" LONG REBAR
WEIGHING 1.502 LB./FT.

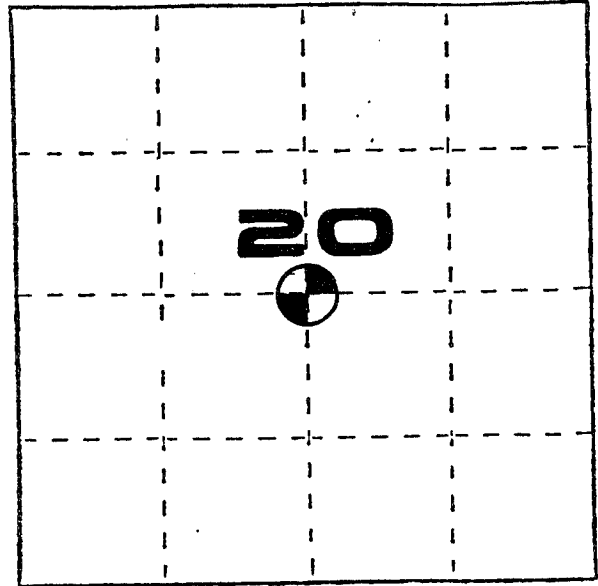
Center of Section 20, T6N, R2W, Town of Fennimore, Grant County, Wisconsin.

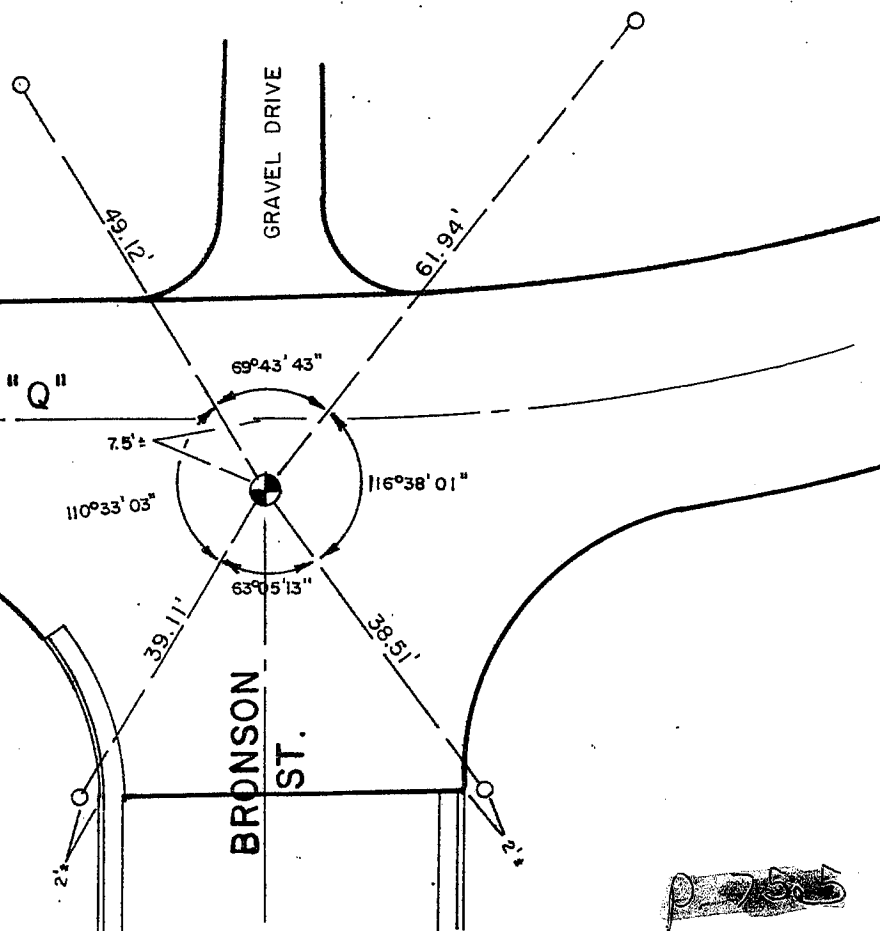
I set the aluminum monument at the center of Section 20, T6N, R2W, using a straight line intersection of the E-W 1/4 line and N-S 1/4 line. This location agrees with several surveys along Bronson Street.

- (d) Show a plan view drawing depicting the relevant monuments and reference ties which is sufficient in detail to enable accurate relocation of the corner monument if the corner monument is disturbed. Indicate north.

- ⊕ CAST ALUMINUM MONUMENT SET
- 3/4" x 24" REBAR SET
