U.S. PUBLIC LAND SURVEY MONUMENT RECORD GRANT COUNTY, WISCONSIN

U. S. PUBLIC LAND SURVEY MONUMENT RECORD

Southeast corner of Section 13,
 Town 6 North, Range 3 West, Town of
 Mt. Ida, Grant County, WI

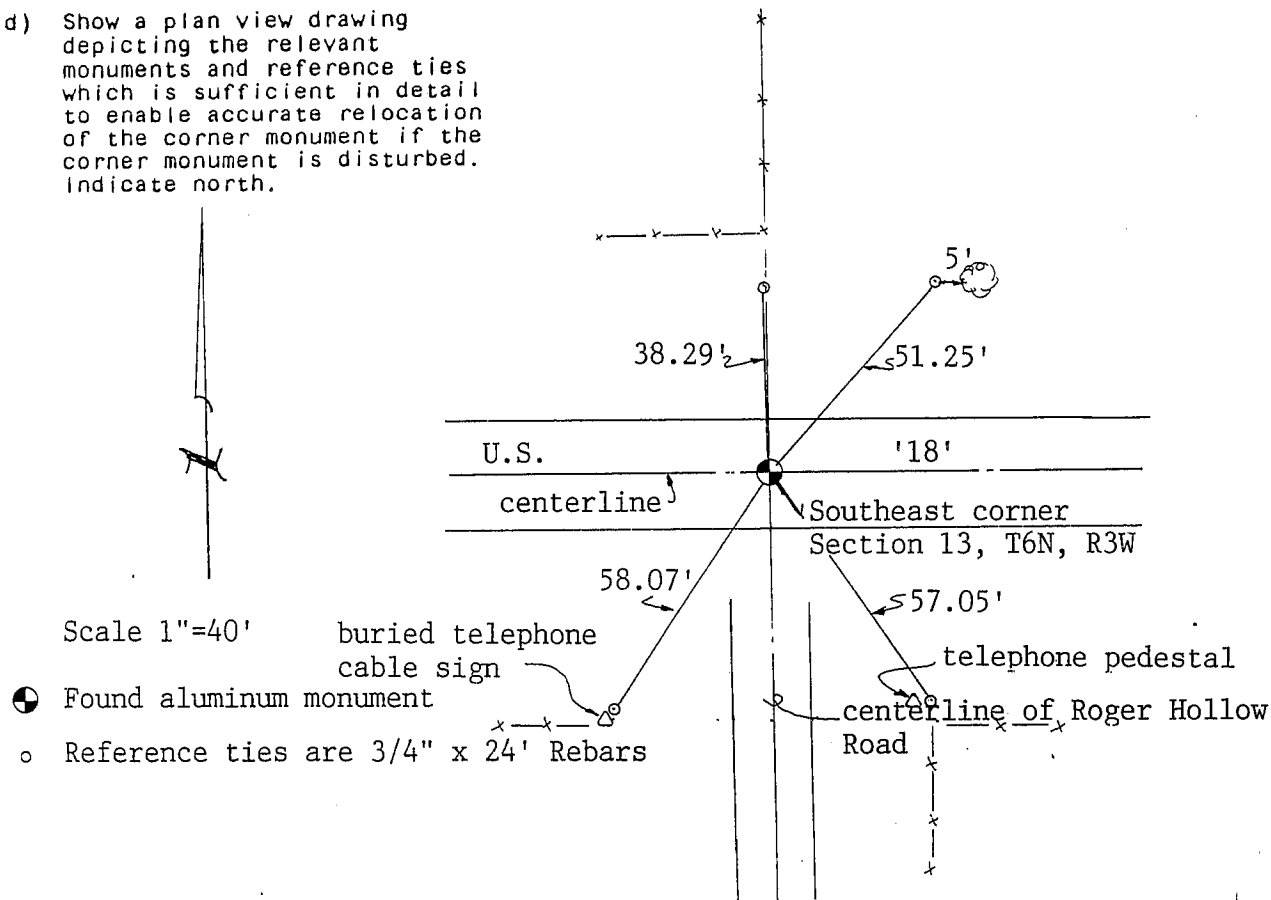
I FOUND THE CORNER AND TIES AS SHOWN. THE INTERSECTION HAS CHANGED FROM THE TIE SHEET DATED SEPTEMBER 17TH, 1993 AND HAS BEEN RECONSTRUCTED AS SHOWN ON DIAGRAM.

I found a aluminum monument in the centerline of U.S. HWY '18' in line with a fence north and the centerline of a town road south. This location fit with the existing monuments at the West 1/4 corner of Section 18, T6N, R2W and the West 1/4 corner of Section 19, T6N, R2W as monumented.

- (d) Show a plan view drawing depicting the relevant monuments and reference ties which is sufficient in detail to enable accurate relocation of the corner monument if the corner monument is disturbed. Indicate north.
