**U.S. PUBLIC LAND SURVEY MONUMENT RECORD - GRANT COUNTY, WI**

Section 33, Town 6 North Range 5 West, Town of Patch Grove (a)

# U. S. PUBLIC LAND SURVEY MONUMENT RECORD

C.O.S. 33 T6N R5W  
of the 4th P.M.  
Town of Patch Grove  
Grant County, Wisconsin.

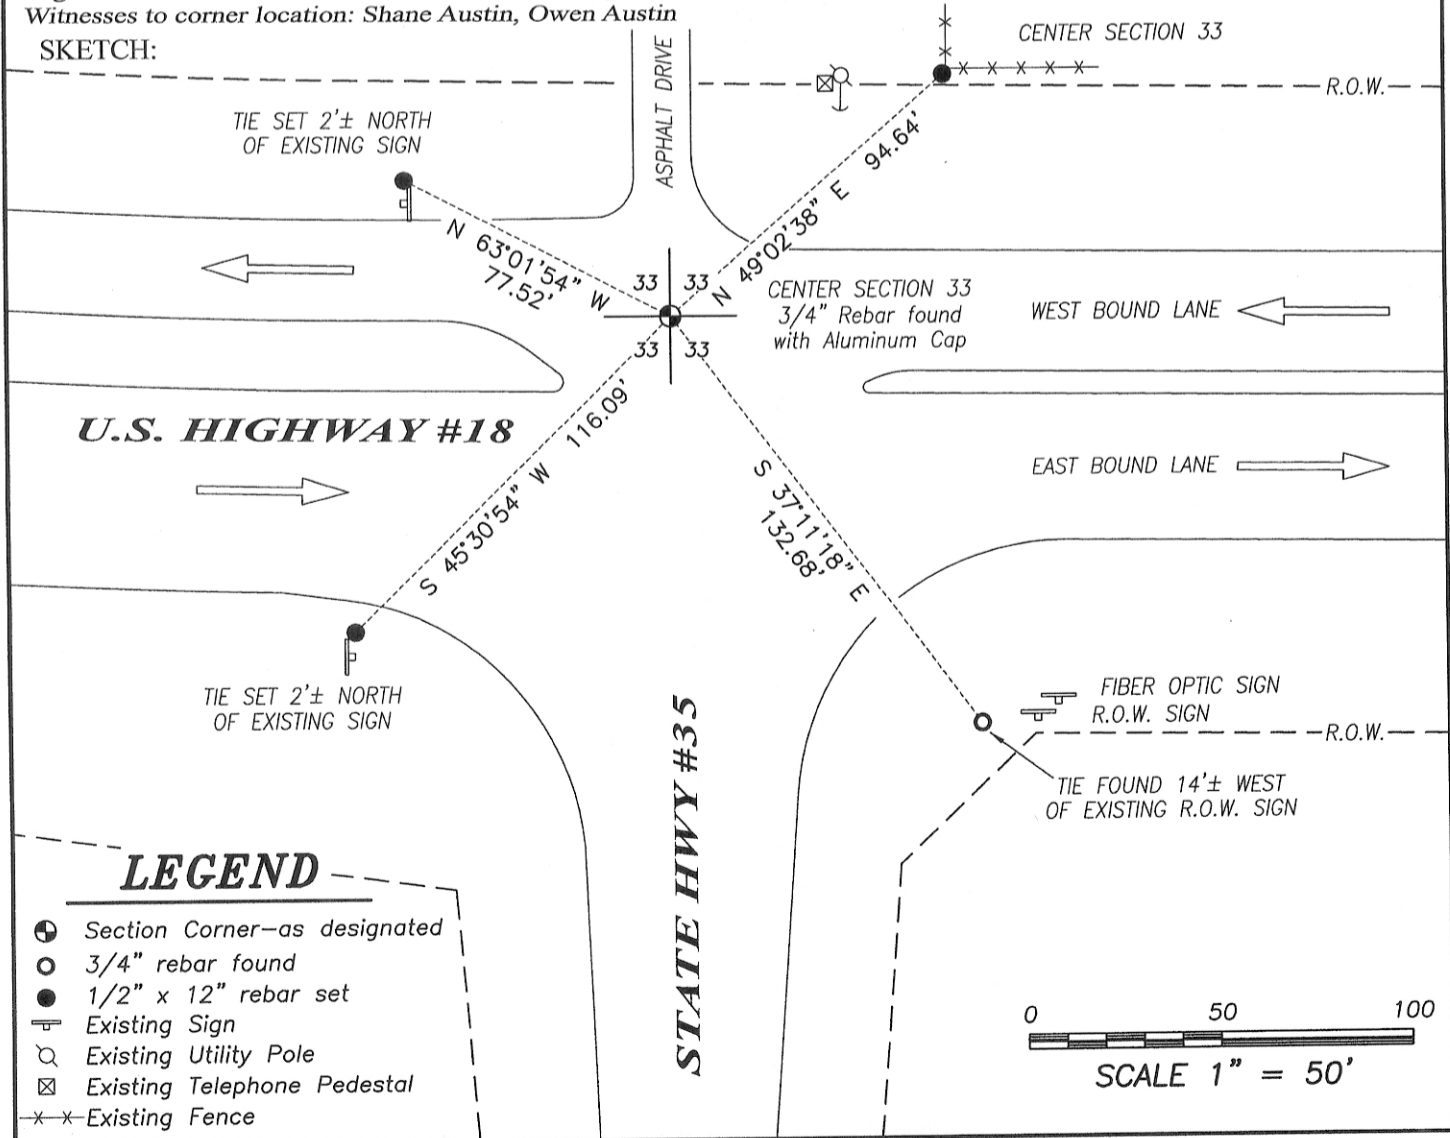
I found the rebar with an Aluminum Cap at the corner location as established by Timothy Moore and I found one witness corner. I set three additional witness corners after I verified it's location. County Coordinates were established using G.P.S. observation NAD 83 (2011) WISCORS.

**DESCRIPTION OF CORNER AND WITNESS MONUMENTS, references and accessories used to perpetuate the original or re-established location of this corner. (c) (d) (e)**

Witnesses to corner location: Shane Austin, Owen Austin  
 SKETCH:

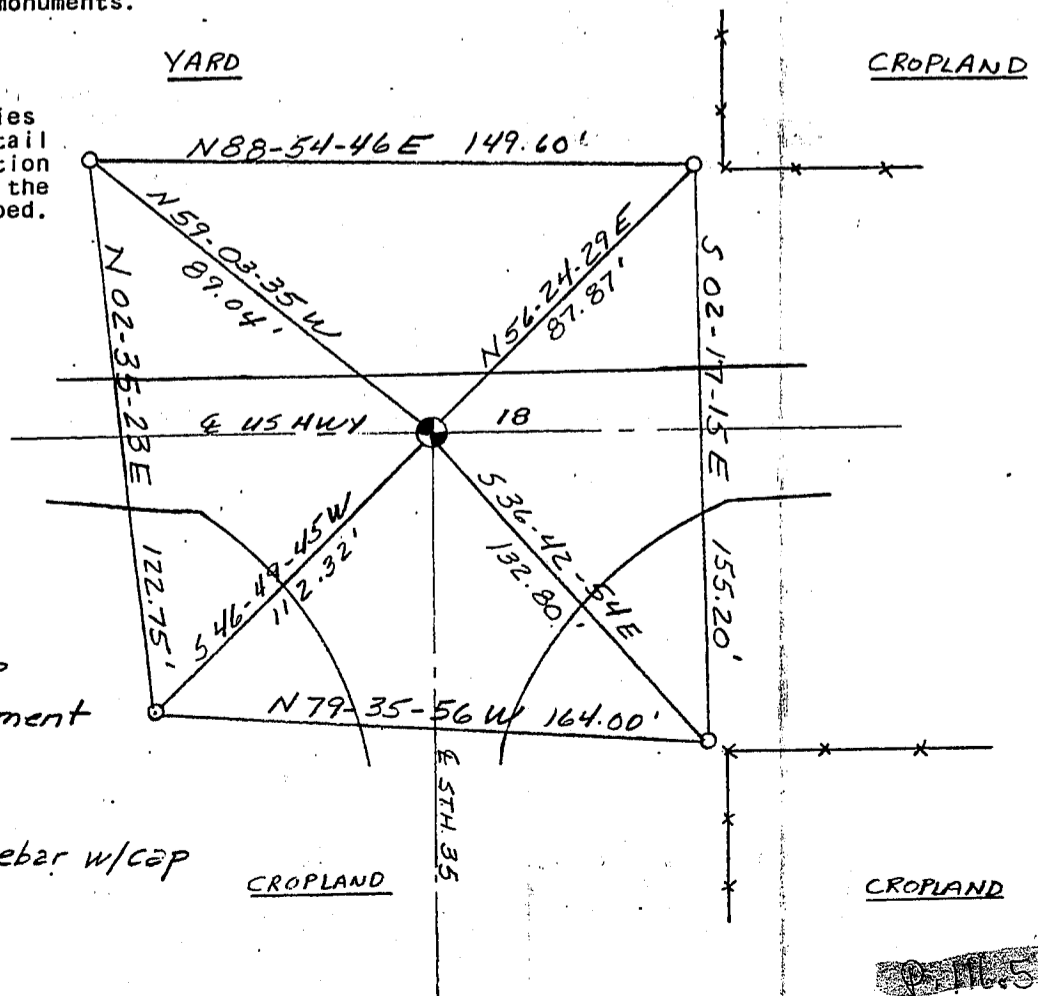
- (d) Show a plan view drawing depicting the relevant monuments and reference ties which is sufficient in detail to enable accurate relocation of the corner monument if the corner monument is disturbed. Indicate north.

No Scale

BEARINGS - WIS GRID

- - 3/4" x 24" rebar w/cap set just below pavement
- - Ref. mons. - 3/4" x 24" rebar w/cap

116.51

Monument was set at a PK nail found at the centerlines of US HWY 18 and S.T.H. 35. This PK nail was referenced to in a 1974 survey done by Homer D. Ralph, Jr. for Charles Finn. This location is also in agreement with the Hwy. R.O.W plat for Division Job No. 9572-A, 1941. Research revealed that the C.O.S had never been previously set.

No - The PK nail replaced appears to have been set according to occupational evidence (roads East, west, and South and fence line north). Calculations would eliminate the quarter corner, quarter corner line intersections and the equi-distant methods.
