Survey Monument Record

CORNER NO. _____ JUN 21 1995
 SECTION 23
 TOWN 7N
 RANGE 2W

TYPE OF MONUMENT Grant Co. Driveable Aluminum
 STATE PLANE COORDINATES: N _____
 E _____
 ELEVATION — M.S.L. DATUM: _____
 THETA ANGLE: _____
 FIELD BOOK: 95-5
 PAGE _____

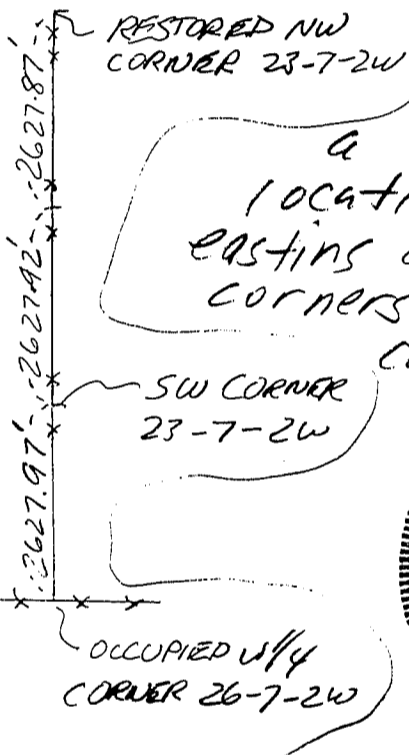
There are no recent survey records of this corner. Occupational evidence is a north-south fence line at the corner location. This fence was accepted for eastings as it checked out well with adjacent corners East and West. The northings of the corner was based on a prorate as shown.

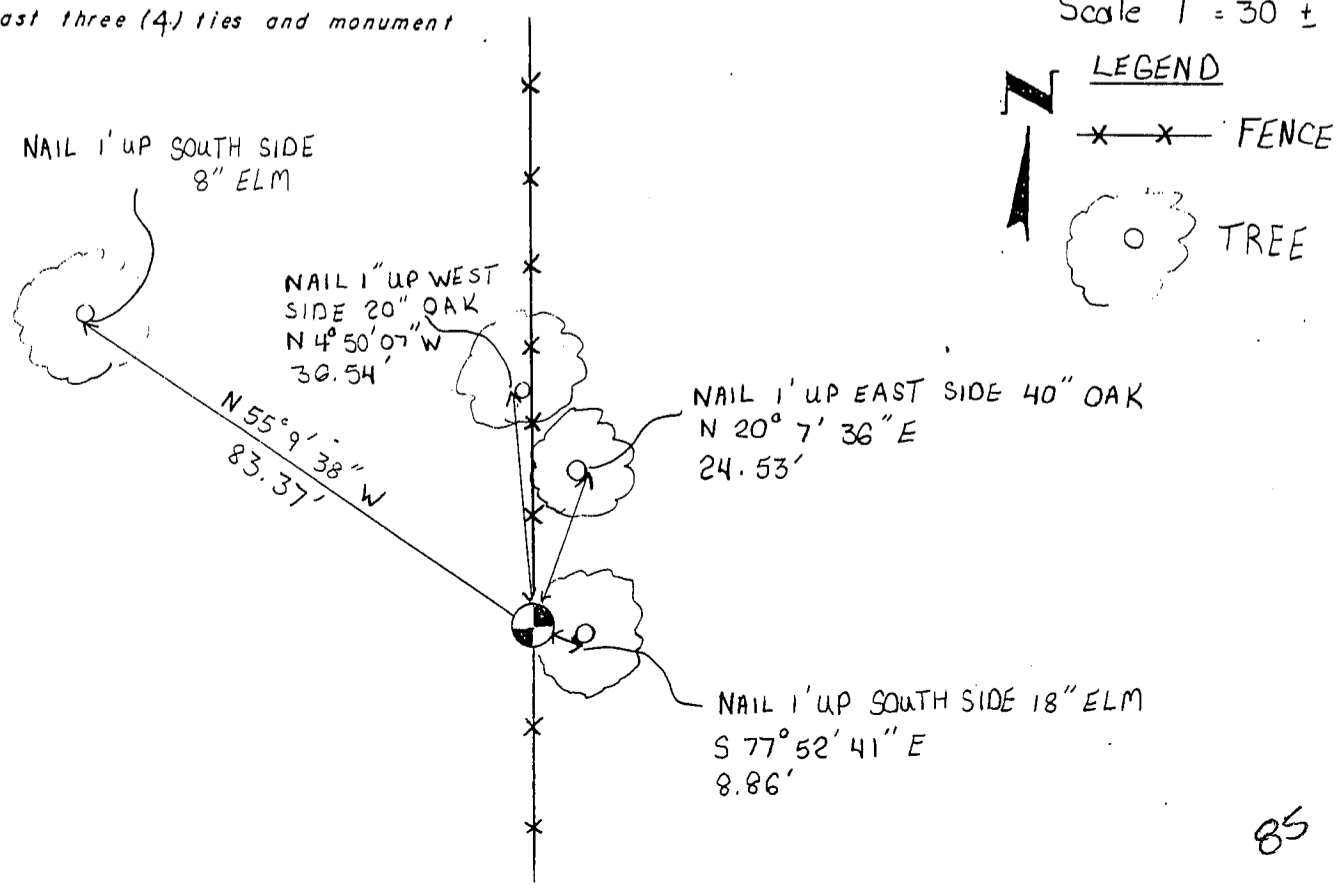
TIE SKETCH

Show at least three (4) ties and monument
