# Survey Monument Record

TYPE OF MONUMENT Grant Co. Driveable Aluminum  
 STATE PLANE COORDINATES: N \_\_\_\_\_  
 E \_\_\_\_\_  
 ELEVATION — M.S.L. DATUM: \_\_\_\_\_  
 THETA ANGLE: \_\_\_\_\_  
 FIELD BOOK: 95-5  
 PAGE \_\_\_\_\_

CORNER NO. \_\_\_\_\_  
 SECTION 23  
 TOWN 7N  
 RANGE 2W

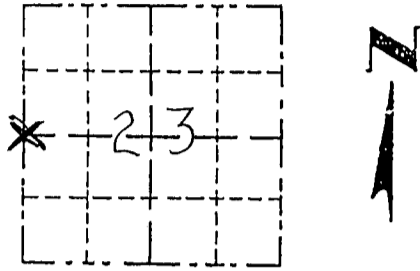
There are no recent survey records of this corner. The restored corner was placed at 1/2 the distance between the NW and SW corners on an existing long standing fence line (north-south). It fell 3.5' east of a straight line between these corners.

N 0-14-43 E  
 2627.87' ~ NW COR  
 W 1/4 COR 23-7-2W  
 N 0-23-52 E  
 2627.92' ~ SW COR

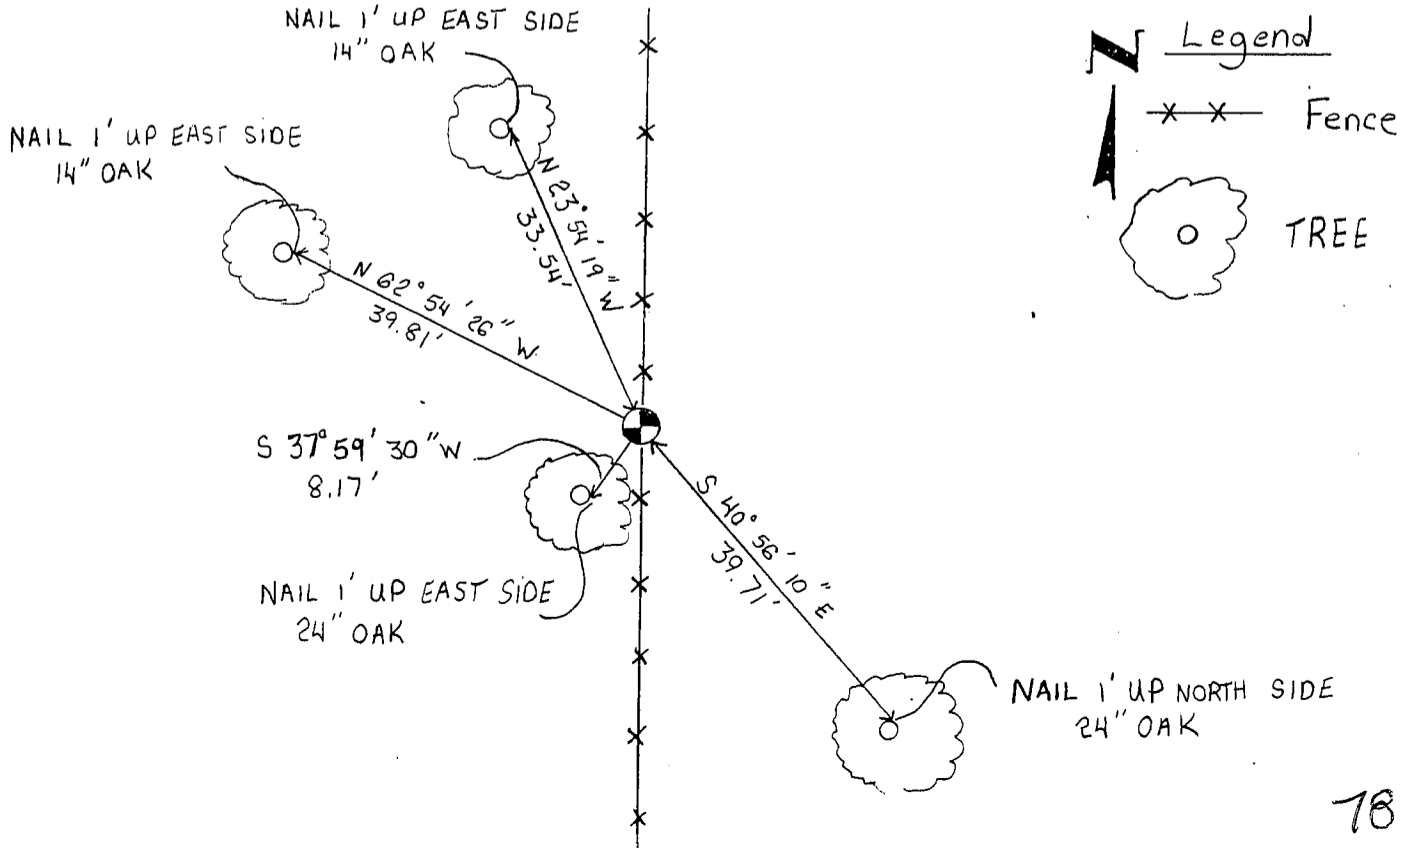
## TIE SKETCH

Show at least three (4) ties and monument
